# Home Inspection Report

123 Anywhere Ln, Hometown, OR 97330

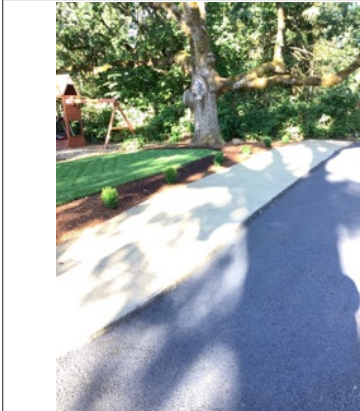
Concrete service walks appeared to be in overall usable condition.

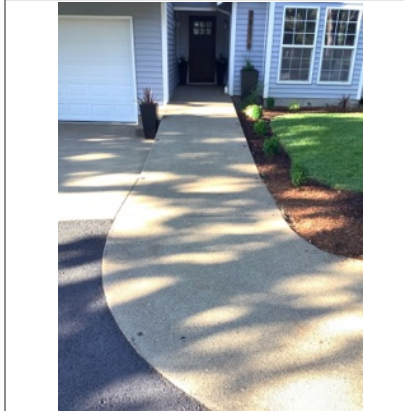
Concrete service walks appeared to be in overall usable condition.

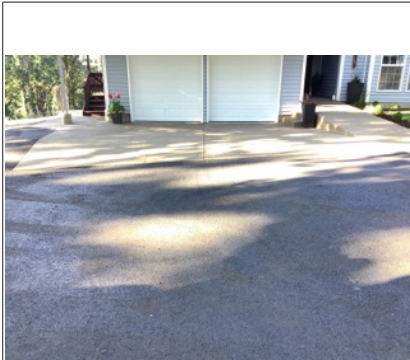
The driveway appeared to be in overall usable condition. Typical cracks were observed at the concrete driveway. Recommend sealing cracks to prevent further deterioration.

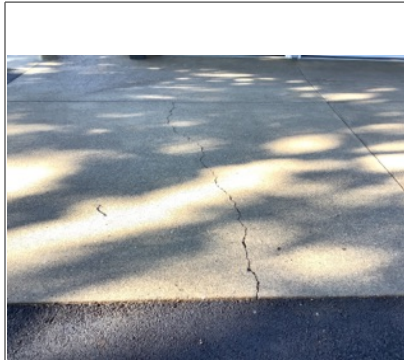
The driveway appeared to be in overall usable condition. Typical cracks were observed at the concrete driveway. Recommend sealing cracks to prevent further deterioration.

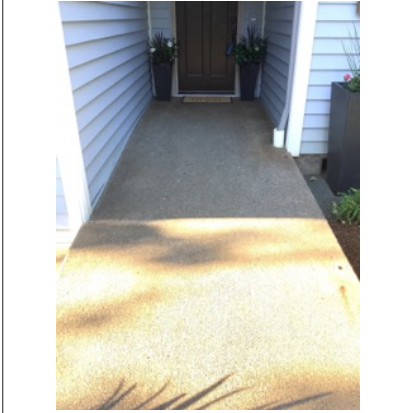
The concrete front porch appeared to be in overall usable condition.

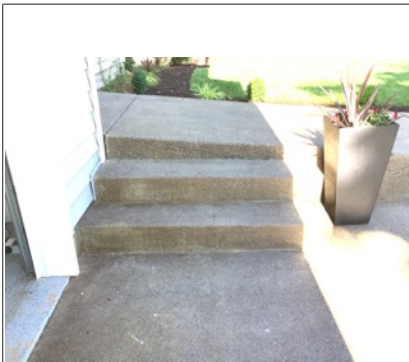
The exterior steps appeared to be in overall usable condition at time of inspection.

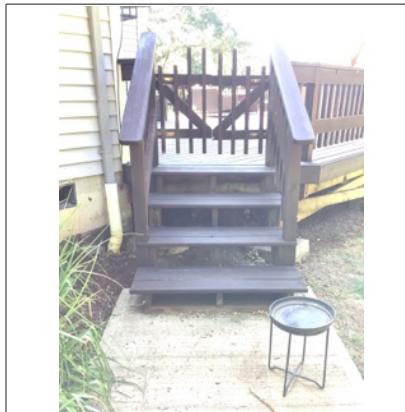
The exterior steps appeared to be in overall usable condition at time of inspection.

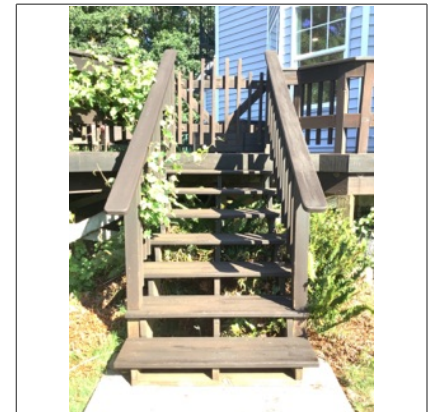
The exterior steps appeared to be in overall usable condition at time of inspection.

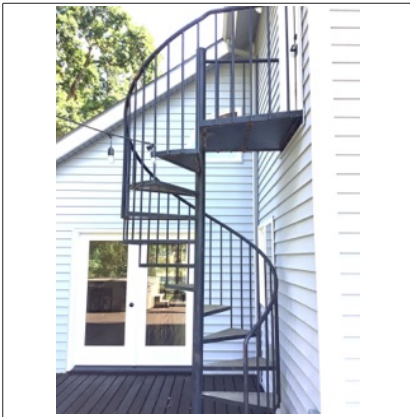
The exterior steps appeared to be in overall usable condition at time of inspection.

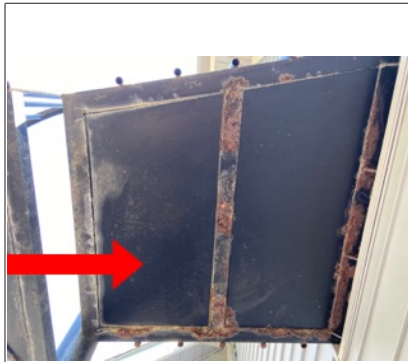
Summary item 1  
Rust/corrosion was observed at the steel frames at the exterior spiral staircase.  
It would be recommended to treat the steel frames at the exterior spiral staircase with a rust inhibitor and perform painting maintenance to prevent further deterioration.  
Inspections and maintenance should be ongoing.

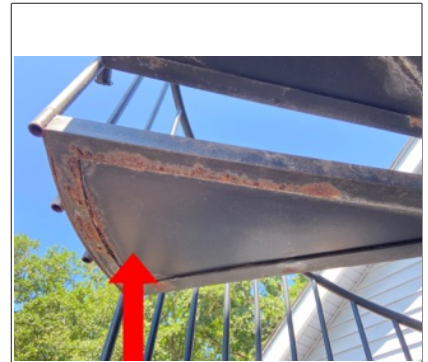
Summary item 1  
Rust/corrosion was observed at the steel frames at the exterior spiral staircase.  
It would be recommended to treat the steel frames at the exterior spiral staircase with a rust inhibitor and perform painting maintenance to prevent further deterioration.  
Inspections and maintenance should be ongoing.

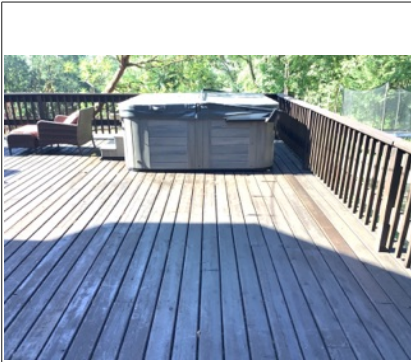
The exterior wood decking appeared to be in overall usable condition. Regular maintenance is recommended to help prolong the life of the deck. Repairs and a future replacement should be anticipated.

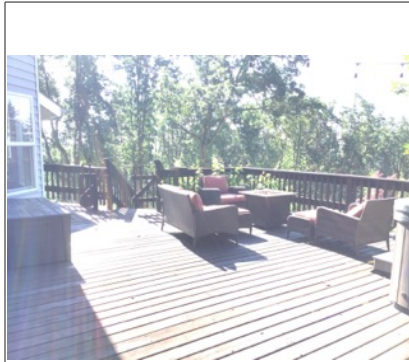
The exterior wood decking appeared to be in overall usable condition. Regular maintenance is recommended to help prolong the life of the deck. Repairs and a future replacement should be anticipated.

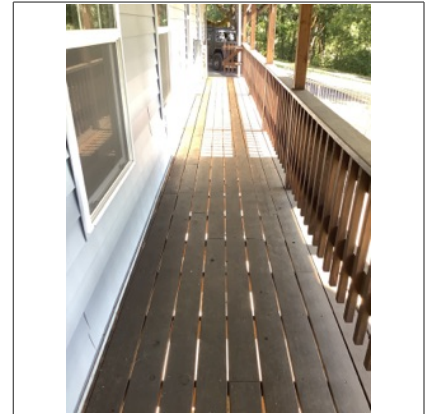
The exterior wood decking appeared to be in overall usable condition. Regular maintenance is recommended to help prolong the life of the deck. Repairs and a future replacement should be anticipated.

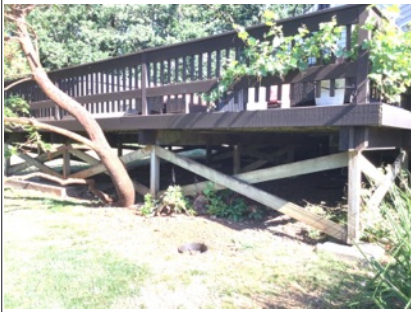
The exterior wood decking appeared to be in overall usable condition. Regular maintenance is recommended to help prolong the life of the deck. Repairs and a future replacement should be anticipated.

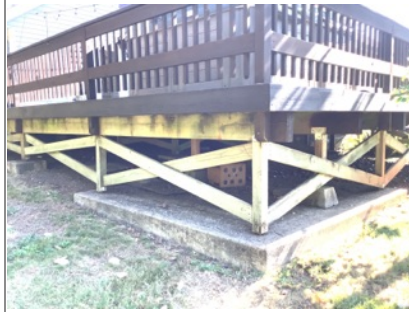
The exterior wood decking appeared to be in overall usable condition. Regular maintenance is recommended to help prolong the life of the deck. Repairs and a future replacement should be anticipated.

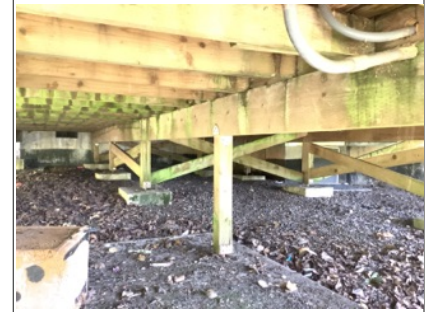
The exterior wood decking appeared to be in overall usable condition. Regular maintenance is recommended to help prolong the life of the deck. Repairs and a future replacement should be anticipated.

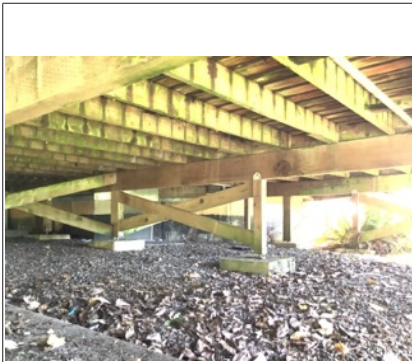
The exterior wood decking appeared to be in overall usable condition. Regular maintenance is recommended to help prolong the life of the deck. Repairs and a future replacement should be anticipated.

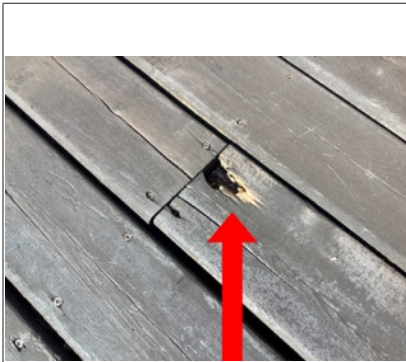
**Summary item 1a**  
A moisture damaged deck board was observed adjacent to the hot tub. Recommend replacing any/all moisture damaged deck boards as needed. It may also be necessary to reset the deck screws to better secure the deck boards in an effort to reduce squeaking and shifting/warping.

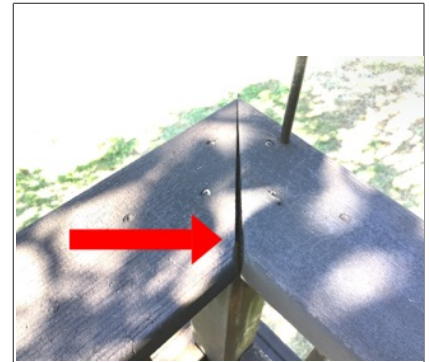
**Summary item 1b**  
Open gaps were observed at the guardrail around the exterior deck at the miter joints/seams. Recommend sealing the open gaps at the guardrail as needed to prevent moisture intrusion which could lead to premature deterioration.

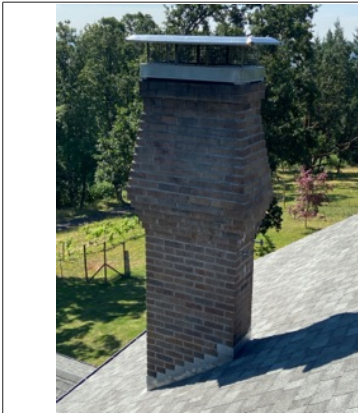
The masonry chimney appeared to be in overall functional condition as viewed from the roof. Flue could not be fully examined so no representation could be made.

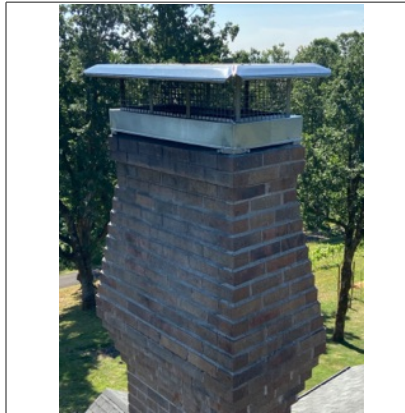
The masonry chimney appeared to be in overall functional condition as viewed from the roof. Flue could not be fully examined so no representation could be made.

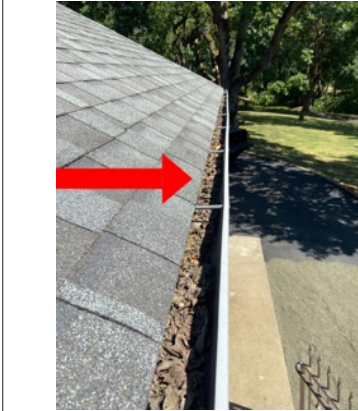
Summary item 1c  
 Debris was observed at the interior of the gutters and downspouts around the perimeter of the home.  
 Plugged gutters/downspouts may lead to moisture intrusion into the crawl space/basement and could potentially impact the foundation.  
 Recommend clearing any/all debris from the gutters and downspouts to promote proper roof drainage.  
 Recommend observing the perimeter drainage for additional signs of blockage and perform cleaning maintenance as needed.

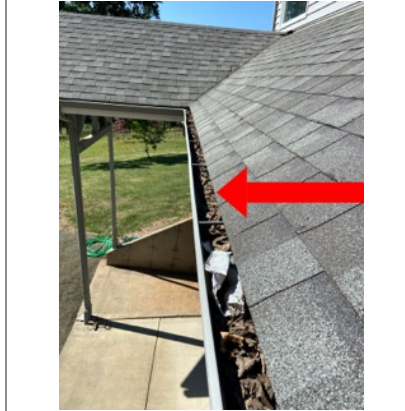
Summary item 1c  
 Debris was observed at the interior of the gutters and downspouts around the perimeter of the home.  
 Plugged gutters/downspouts may lead to moisture intrusion into the crawl space/basement and could potentially impact the foundation.  
 Recommend clearing any/all debris from the gutters and downspouts to promote proper roof drainage.  
 Recommend observing the perimeter drainage for additional signs of blockage and perform cleaning maintenance as needed.

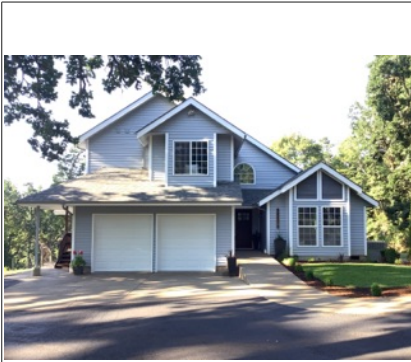
The exterior siding and trim appeared to be intact and in overall functional condition unless noted.  
 Recommend ongoing caulking/painting maintenance around the exterior of the home.

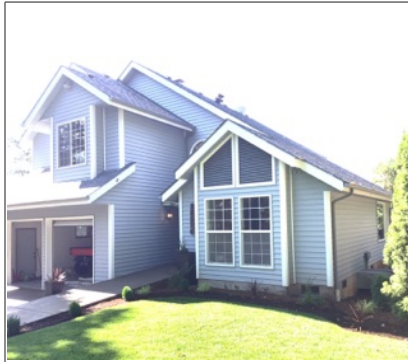
The exterior siding and trim appeared to be intact and in overall functional condition unless noted.  
 Recommend ongoing caulking/painting maintenance around the exterior of the home.

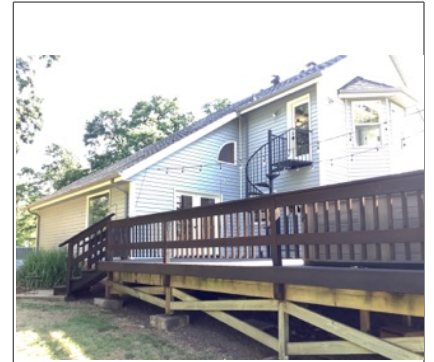
The exterior siding and trim appeared to be intact and in overall functional condition unless noted.  
 Recommend ongoing caulking/painting maintenance around the exterior of the home.

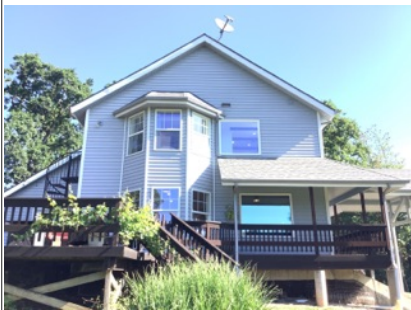
The exterior siding and trim appeared to be intact and in overall functional condition unless noted.  
 Recommend ongoing caulking/painting maintenance around the exterior of the home.

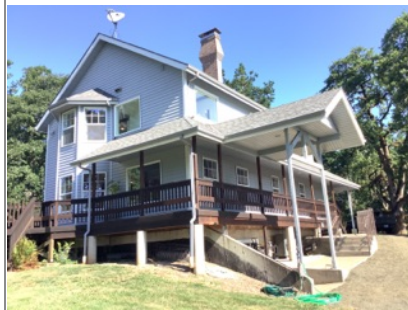
The exterior siding and trim appeared to be intact and in overall functional condition unless noted.  
 Recommend ongoing caulking/painting maintenance around the exterior of the home.

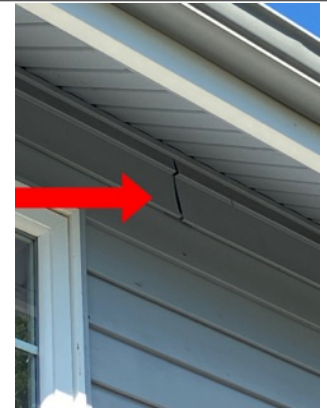
Summary item 1d  
 A small gap was observed at the vinyl siding on the East/NE side of the home.  
 Recommend adjusting the vinyl siding as needed to eliminate the open gap where indicated.

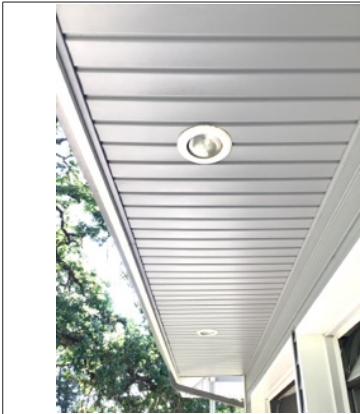
Soffits appeared to be in overall functional condition where safely accessible unless noted. Recommend ongoing caulking/painting maintenance around the exterior of the home.

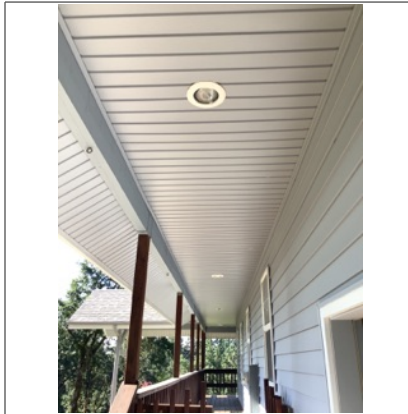
Soffits appeared to be in overall functional condition where safely accessible unless noted. Recommend ongoing caulking/painting maintenance around the exterior of the home.

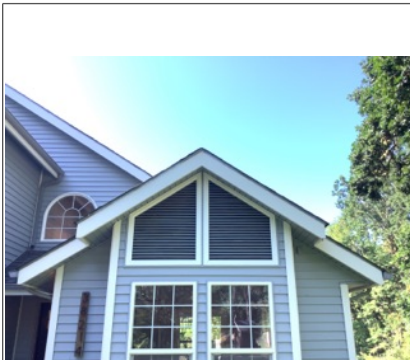
Fascia boards (where visible/accessible) appeared to be in overall functional condition unless noted. The fascia & bargeboards were completely concealed by metal flashings and could not be evaluated

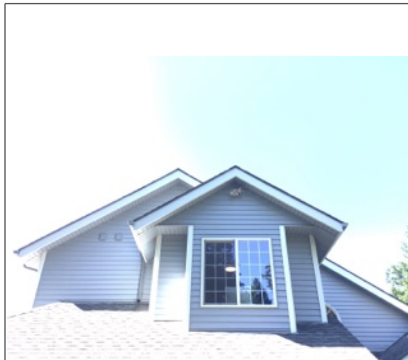
Fascia boards (where visible/accessible) appeared to be in overall functional condition unless noted. The fascia & bargeboards were completely concealed by metal flashings and could not be evaluated

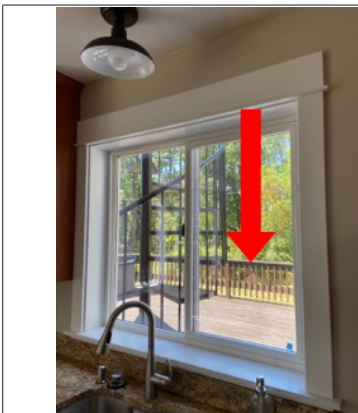
Summary item 1e  
 Failed window seals were observed and/or suspected at multiple windows throughout the home which is widely considered to be a cosmetic concern.  
 The windows in question were marked with small pieces of blue painters tape for future identification.  
 Recommend further evaluation or all windows throughout the home by a licensed contractor and repair as needed.  
 Additional windows with compromised seals may be present but could not be identified due to weather and/or lighting.

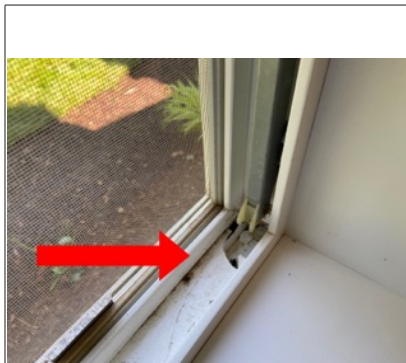
Summary item 1f  
 A detached window channel balance and a broken frame was observed at the North facing/NW window in the living room.  
 Recommend a licensed contractor evaluate and repair or replace the window as needed.

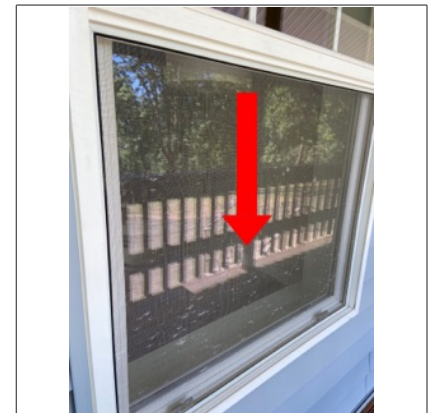
Summary item 1g  
 Damaged, oxidized and missing screens were observed at multiple windows throughout the home at time of inspection.  
 Recommend repair/replacement of the damaged, oxidized or missing screens as deemed necessary

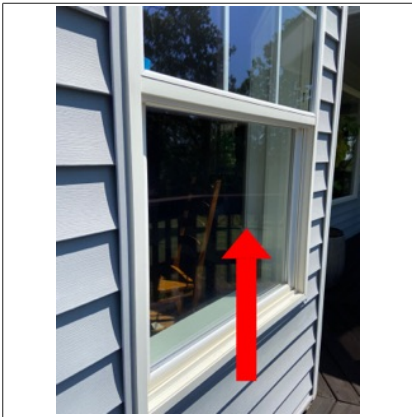
Summary item 1g  
 Damaged, oxidized and missing screens were observed at multiple windows throughout the home at time of inspection. Recommend repair/replacement of the damaged, oxidized or missing screens as deemed necessary

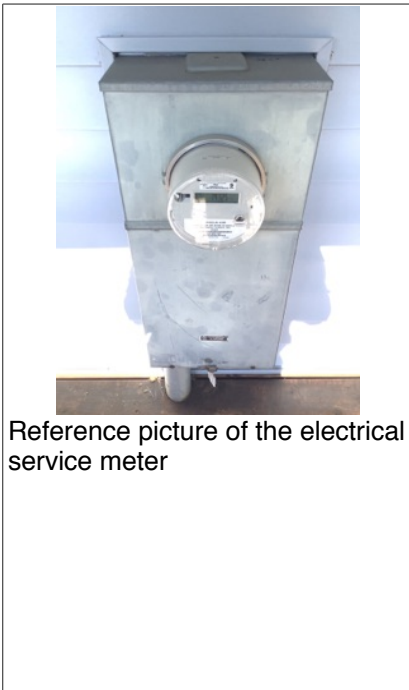
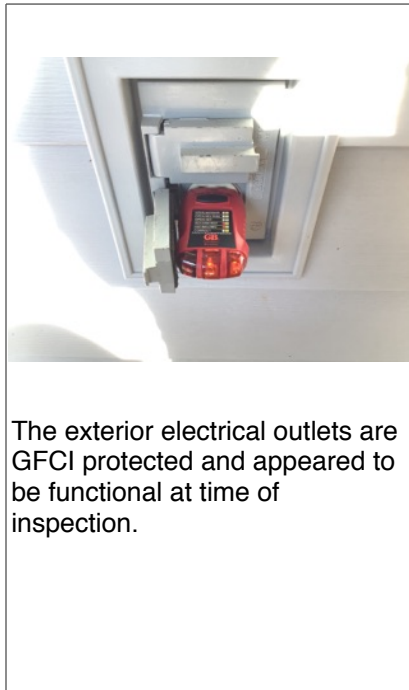
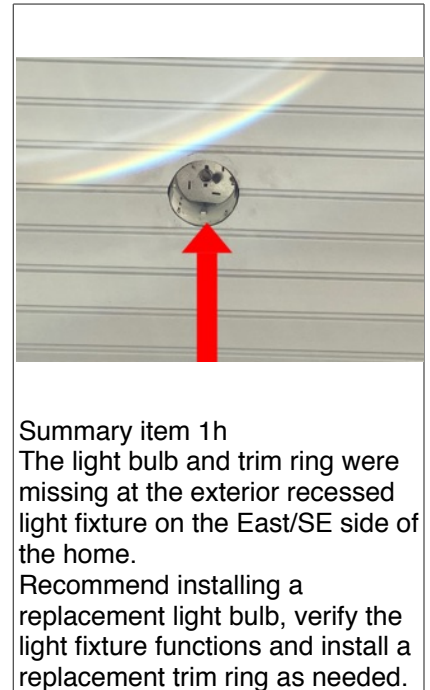
**Building(s) Exterior Wall Construction**

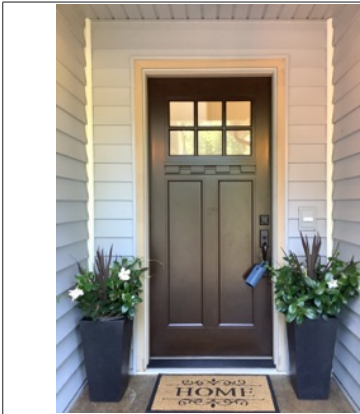
The exterior doors appeared to be in overall functional condition unless noted.

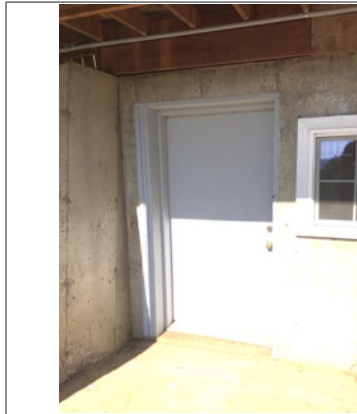
The exterior doors appeared to be in overall functional condition unless noted.

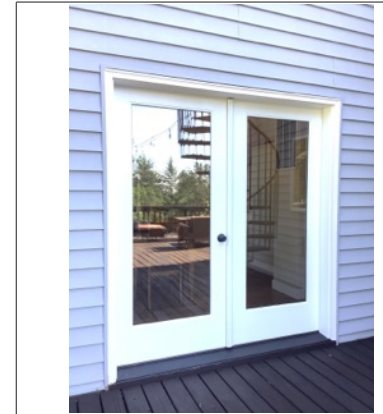
The exterior doors appeared to be in overall functional condition unless noted.

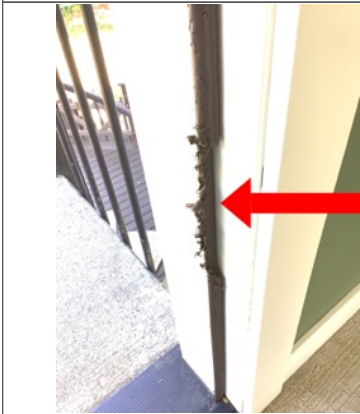
Summary item 1i  
Damaged/torn weatherstripping was observed at the upper west facing exterior door at the top of the spiral staircase.  
Recommend repair or replacement of the damaged/torn weatherstripping as needed.

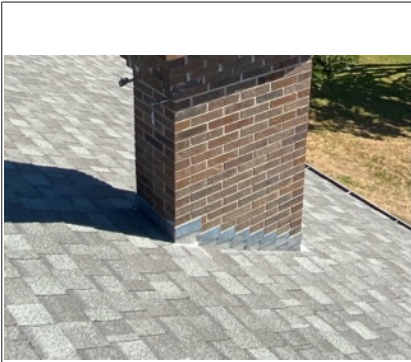
Chimney flashings appeared to be in overall functional condition. No active water leaks were apparent at time of inspection.

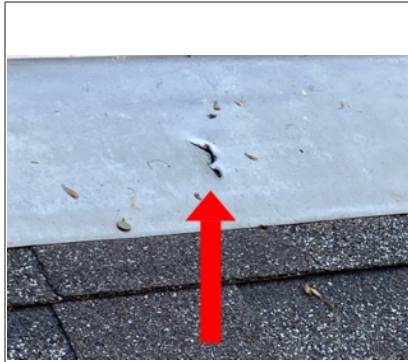
Summary item 1j  
Minor damage was observed at the sheet metal end wall flashing on the north side of the home above the front porch. Recommend repairing/sealing the damaged section of end wall flashing as needed to prevent any potential moisture intrusion.

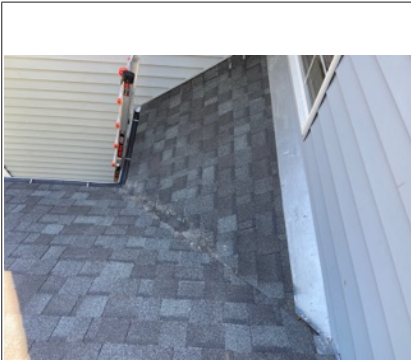
The asphalt valley at the roof appeared to be in overall functional condition. No active water leakage was apparent at the roof valley(s) at time of inspection.

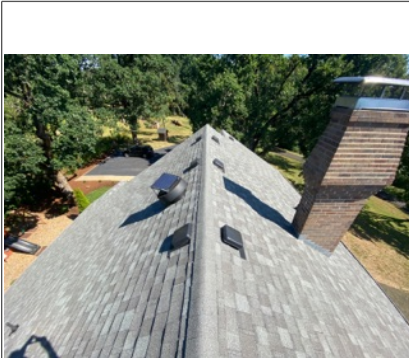
The asphalt roof coverings appeared to be in overall functional condition at time of inspection.  
 No evidence of water leakage was observed at time of inspection.

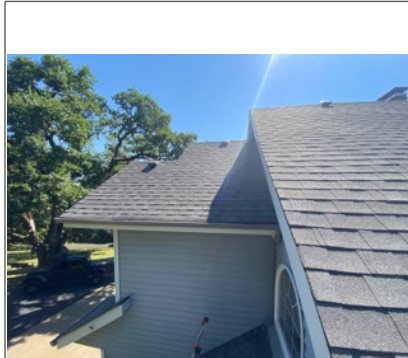
The asphalt roof coverings appeared to be in overall functional condition at time of inspection.  
 No evidence of water leakage was observed at time of inspection.

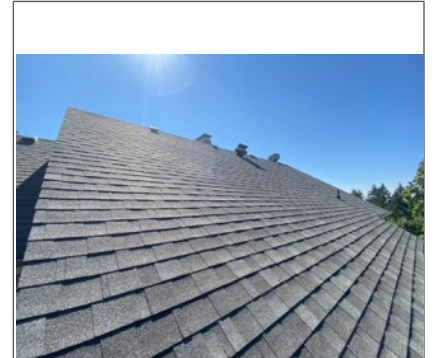
The asphalt roof coverings appeared to be in overall functional condition at time of inspection.  
 No evidence of water leakage was observed at time of inspection.

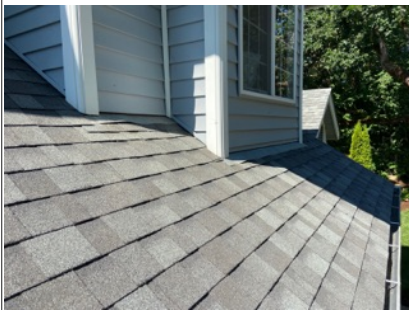
The asphalt roof coverings appeared to be in overall functional condition at time of inspection.  
 No evidence of water leakage was observed at time of inspection.

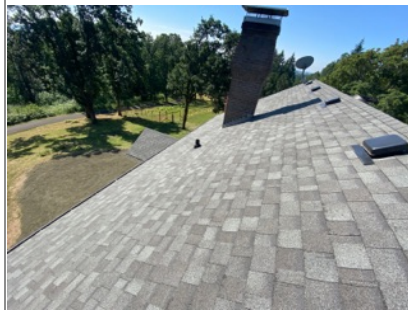
The asphalt roof coverings appeared to be in overall functional condition at time of inspection.  
 No evidence of water leakage was observed at time of inspection.

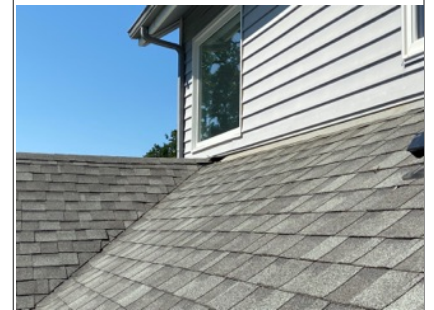
The asphalt roof coverings appeared to be in overall functional condition at time of inspection.  
 No evidence of water leakage was observed at time of inspection.

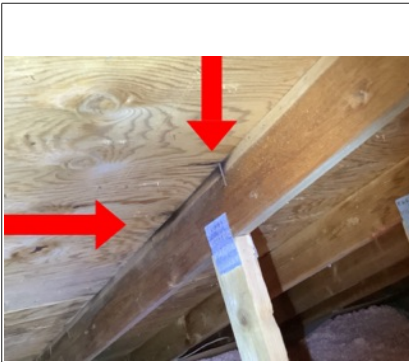
Summary item 2  
 Evidence of minor moisture intrusion was observed at the roof sheathing in the attic on the West side over the stairway (approximately).  
 The roof sheathing was dry and no signs of active water leaks were observed which may indicate the staining was due to water leakage prior to the roof replacement.  
 Recommend monitoring the roof/attic for any signs of water leaks and repair as needed.

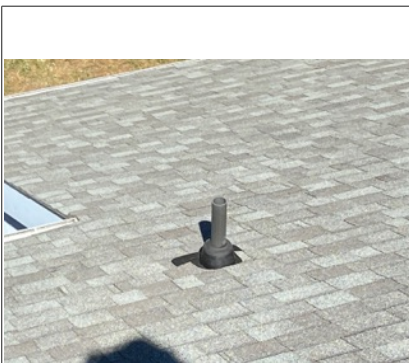
The plumbing vent flashings appeared to be intact and in overall functional condition at time of the inspection.

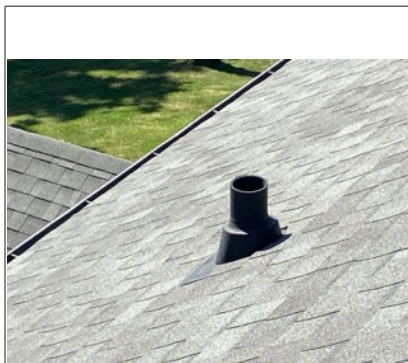
The plumbing vent flashings appeared to be intact and in overall functional condition at time of the inspection.

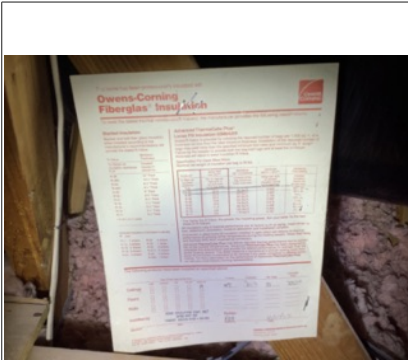
Reference picture of the insulation rating posted in the attic

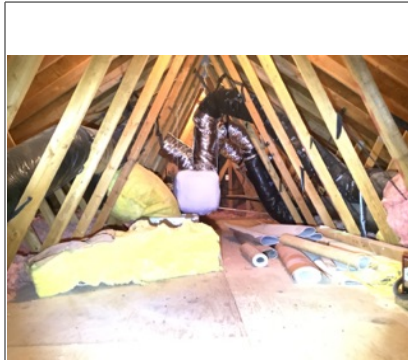
Roof/attic framing, roof sheathing and insulation appeared to be in overall functional condition where accessible.

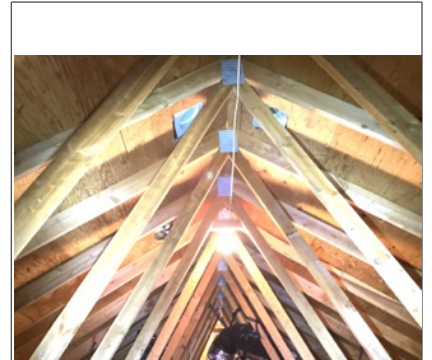
Roof/attic framing, roof sheathing and insulation appeared to be in overall functional condition where accessible.

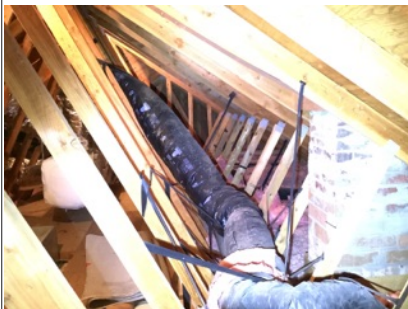
Roof/attic framing, roof sheathing and insulation appeared to be in overall functional condition where accessible.

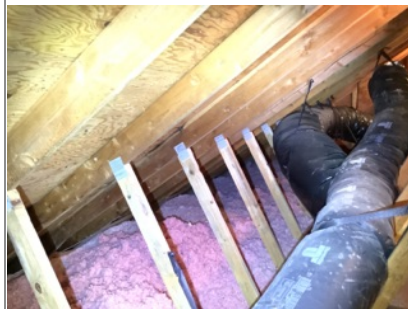
Roof/attic framing, roof sheathing and insulation appeared to be in overall functional condition where accessible.

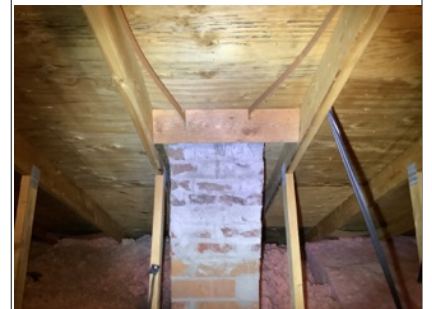
Roof/attic framing, roof sheathing and insulation appeared to be in overall functional condition where accessible.

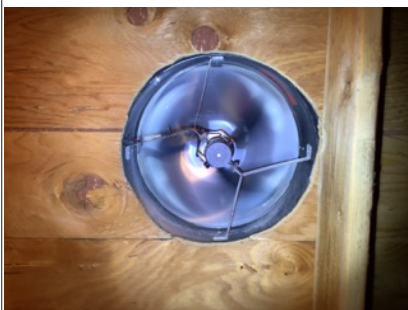
Roof/attic framing, roof sheathing and insulation appeared to be in overall functional condition where accessible.

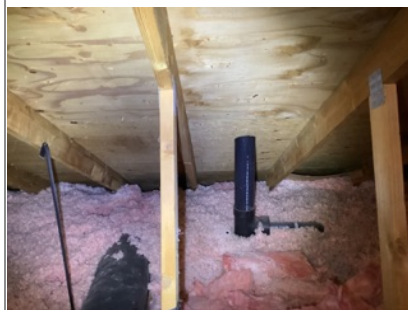
Roof/attic framing, roof sheathing and insulation appeared to be in overall functional condition where accessible.

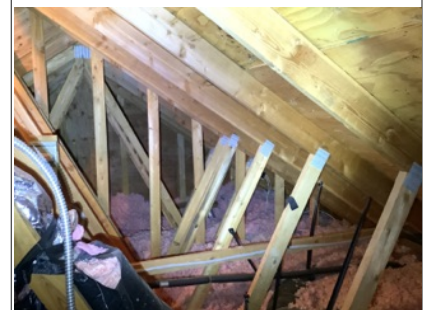
Roof/attic framing, roof sheathing and insulation appeared to be in overall functional condition where accessible.

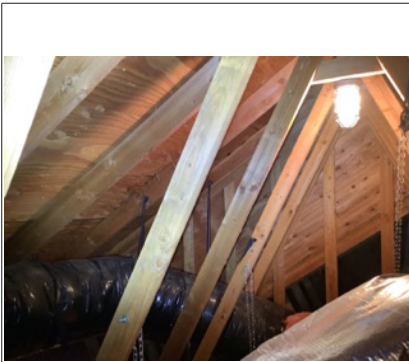
Roof/attic framing, roof sheathing and insulation appeared to be in overall functional condition where accessible.

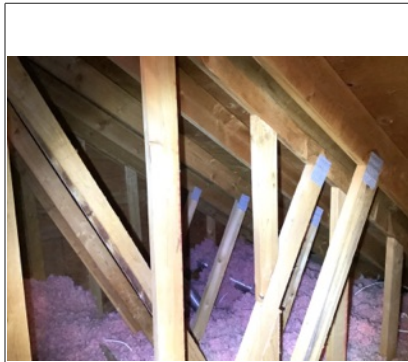
Roof/attic framing, roof sheathing and insulation appeared to be in overall functional condition where accessible.

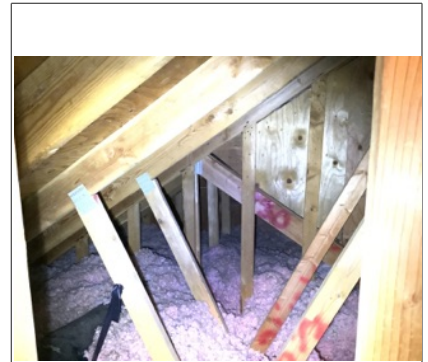
Roof/attic framing, roof sheathing and insulation appeared to be in overall functional condition where accessible.

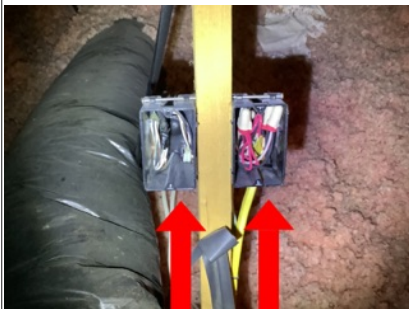
Summary item 7  
Open electrical junction boxes were observed in the attic north of the attic access.  
Recommend installation of cover plates at any/all open electrical junction boxes.

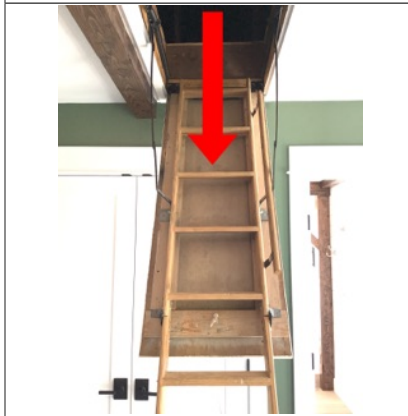
Summary item 1k  
No insulation was installed at the attic access panel/pull down ladder in the Primary Bedroom.  
Recommend installing insulation at the top side of the attic access panel to prevent heat loss if deemed necessary.

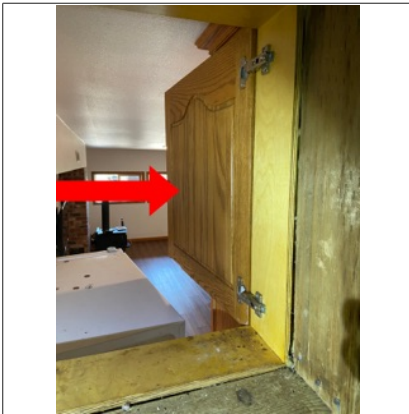
Summary item 11  
Missing insulation was observed at the interior crawl space access panel in the basement. Recommend securing insulation at the interior crawl space access panel.

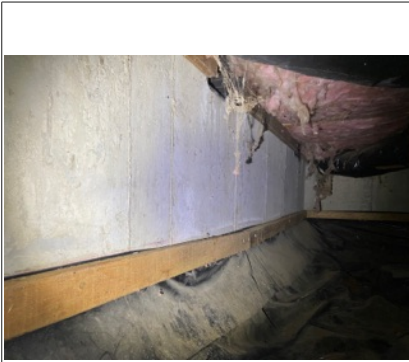
The poured concrete foundation appeared to be in overall functional condition where visible.

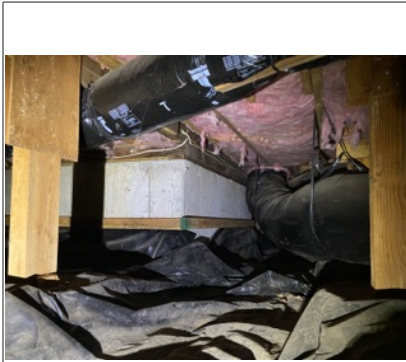
The poured concrete foundation appeared to be in overall functional condition where visible.

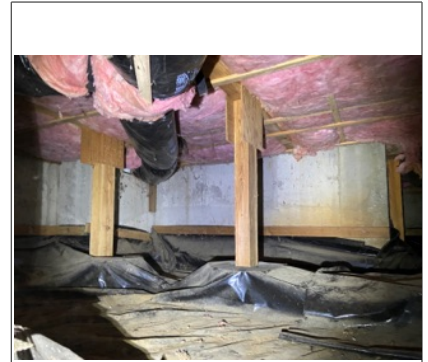
The poured concrete foundation appeared to be in overall functional condition where visible.

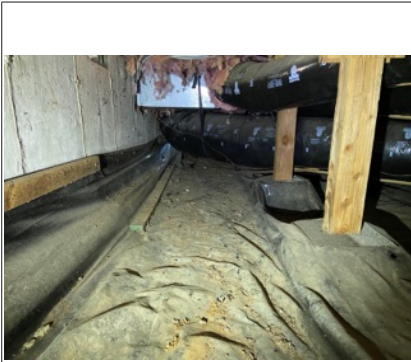
The crawl space was completely dry at time of inspection with no signs of past excessive moisture. Crawl spaces in Oregon may experience moisture intrusion periodically and should be monitored. Inspector cannot predict if, when or how much water may enter the crawl space at any given point.

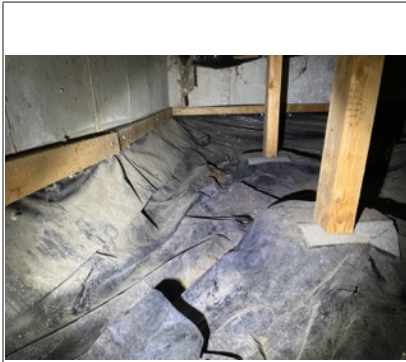
The crawl space was completely dry at time of inspection with no signs of past excessive moisture. Crawl spaces in Oregon may experience moisture intrusion periodically and should be monitored. Inspector cannot predict if, when or how much water may enter the crawl space at any given point.

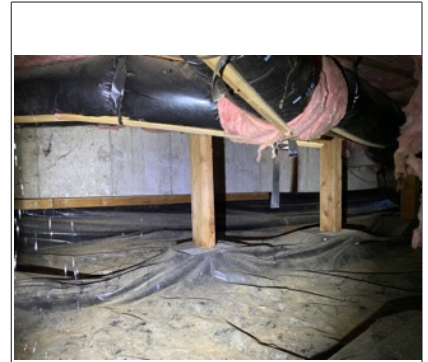
The crawl space was completely dry at time of inspection with no signs of past excessive moisture. Crawl spaces in Oregon may experience moisture intrusion periodically and should be monitored. Inspector cannot predict if, when or how much water may enter the crawl space at any given point.

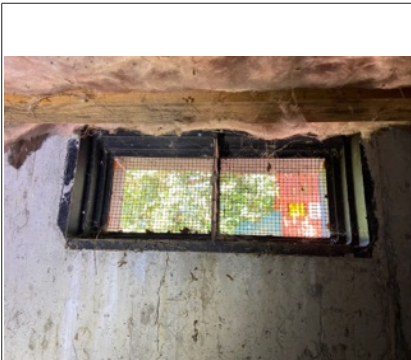
Crawl space ventilation appeared to be adequate for the size/style of home.

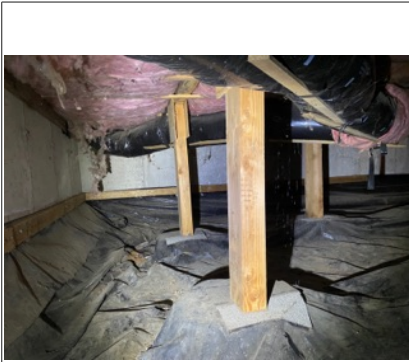
The structural framing viewed from the crawl space appeared to be in overall functional condition where accessible/visible unless noted otherwise. No significant structural deficiencies were apparent at time of inspection.

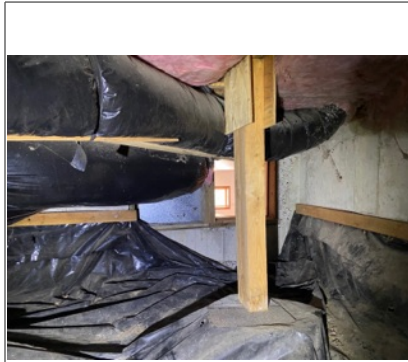
The structural framing viewed from the crawl space appeared to be in overall functional condition where accessible/visible unless noted otherwise. No significant structural deficiencies were apparent at time of inspection.

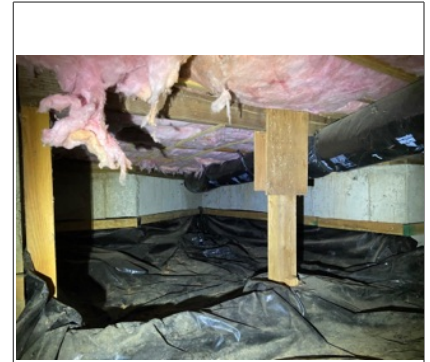
The structural framing viewed from the crawl space appeared to be in overall functional condition where accessible/visible unless noted otherwise. No significant structural deficiencies were apparent at time of inspection.

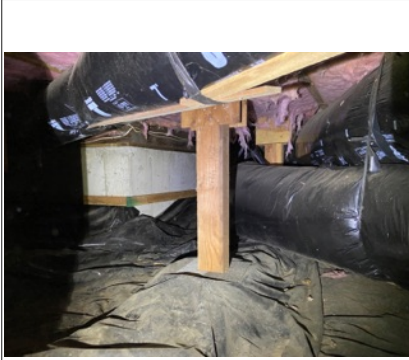
The structural framing viewed from the crawl space appeared to be in overall functional condition where accessible/visible unless noted otherwise. No significant structural deficiencies were apparent at time of inspection.

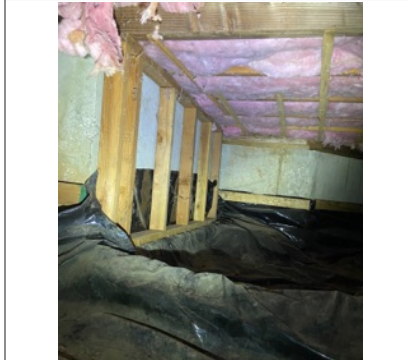
The structural framing viewed from the crawl space appeared to be in overall functional condition where accessible/visible unless noted otherwise. No significant structural deficiencies were apparent at time of inspection.

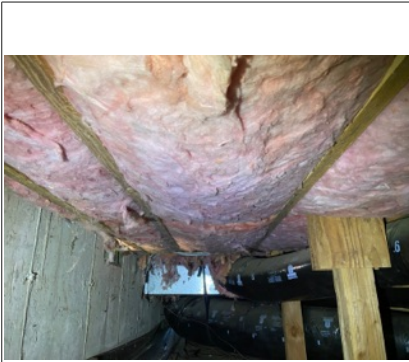
Insulation at the subfloor appeared to be intact and in overall adequate condition where accessible.  
Insulation limits the ability to fully evaluate the subfloor under the home.  
Insulation was left undisturbed during the process of inspecting the home.

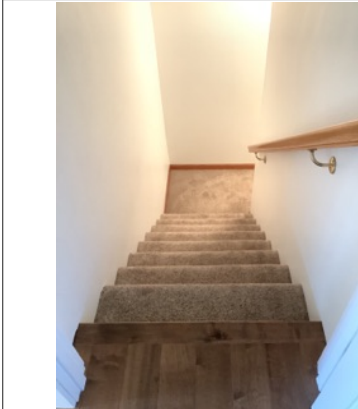
Interior stairs & handrails appear to be in overall satisfactory/usable condition.

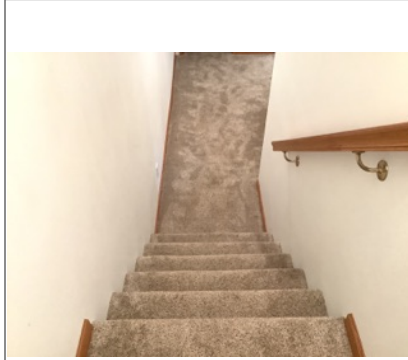
Interior stairs & handrails appear to be in overall satisfactory/usable condition.

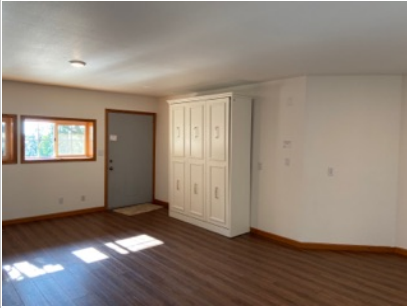
The basement walls were inspected using a Flir E6 model infrared camera. No visible signs of moisture intrusion were apparent at time of inspection. Basements are prone to leakage and the current dry condition of the basement is subject to change. Recommend monitoring the basement for signs of moisture and mitigate as needed. Recommend reviewing the sellers disclosure regarding the basement and any past moisture issues.

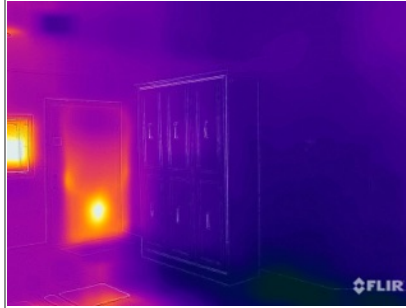
The basement walls were inspected using a Flir E6 model infrared camera. No visible signs of moisture intrusion were apparent at time of inspection. Basements are prone to leakage and the current dry condition of the basement is subject to change. Recommend monitoring the basement for signs of moisture and mitigate as needed. Recommend reviewing the sellers disclosure regarding the basement and any past moisture issues.

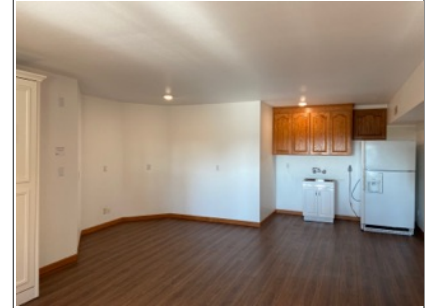
The basement walls were inspected using a Flir E6 model infrared camera. No visible signs of moisture intrusion were apparent at time of inspection. Basements are prone to leakage and the current dry condition of the basement is subject to change. Recommend monitoring the basement for signs of moisture and mitigate as needed. Recommend reviewing the sellers disclosure regarding the basement and any past moisture issues.

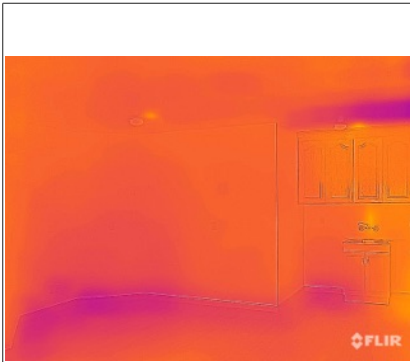
The basement walls were inspected using a Flir E6 model infrared camera. No visible signs of moisture intrusion were apparent at time of inspection. Basements are prone to leakage and the current dry condition of the basement is subject to change. Recommend monitoring the basement for signs of moisture and mitigate as needed. Recommend reviewing the sellers disclosure regarding the basement and any past moisture issues.

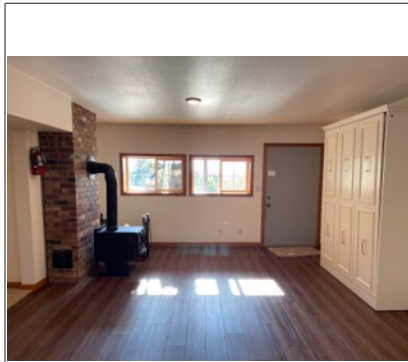
The basement walls were inspected using a Flir E6 model infrared camera. No visible signs of moisture intrusion were apparent at time of inspection. Basements are prone to leakage and the current dry condition of the basement is subject to change. Recommend monitoring the basement for signs of moisture and mitigate as needed. Recommend reviewing the sellers disclosure regarding the basement and any past moisture issues.

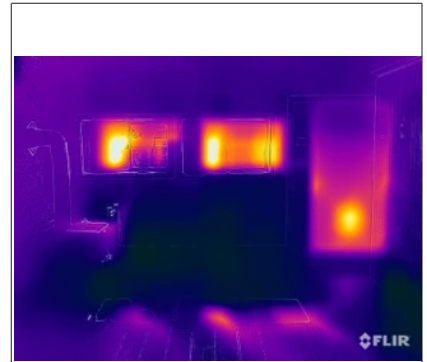
The basement walls were inspected using a Flir E6 model infrared camera. No visible signs of moisture intrusion were apparent at time of inspection. Basements are prone to leakage and the current dry condition of the basement is subject to change. Recommend monitoring the basement for signs of moisture and mitigate as needed. Recommend reviewing the sellers disclosure regarding the basement and any past moisture issues.

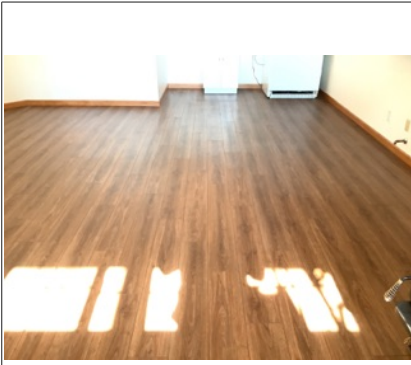
The basement is fully finished. The foundation, mudsill, columns/beams, joists and subfloor were not visible due to the ceiling, wall and floor covering

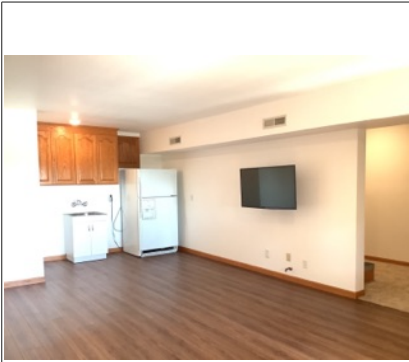
The basement is fully finished. The foundation, mudsill, columns/beams, joists and subfloor were not visible due to the ceiling, wall and floor covering

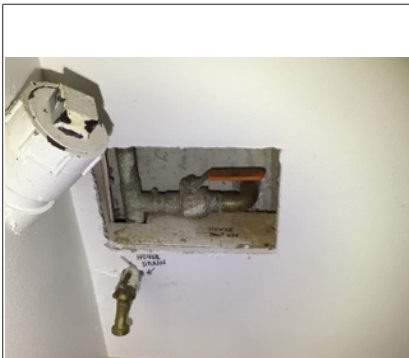
Reference picture of the primary water shut off valve in the basement

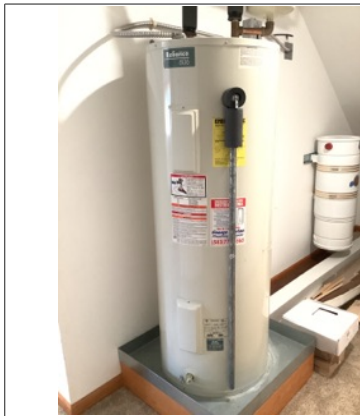
Reference picture of the 80 gallon electric water heater

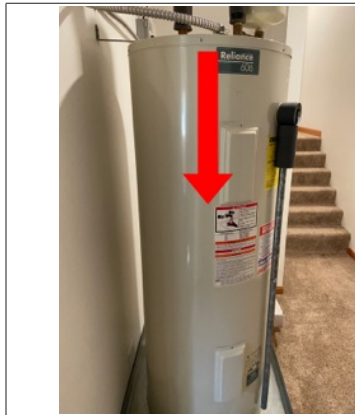
The installed water heater appeared to be functioning properly at time of inspection. Hot water was effectively delivered to all necessary points throughout the home. Recommend budgeting for a replacement due to age of equipment.

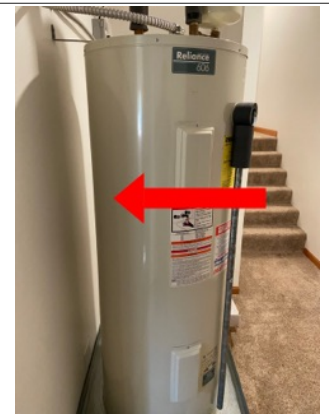
Recommend installation of an additional seismic restraints at the water heater as required

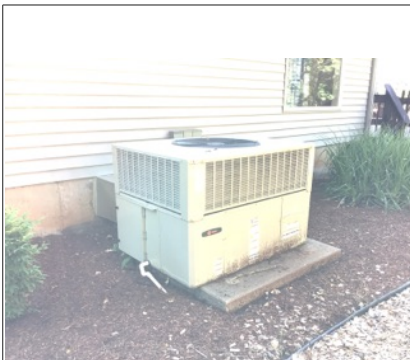
Reference picture of the Trane packaged heat pump

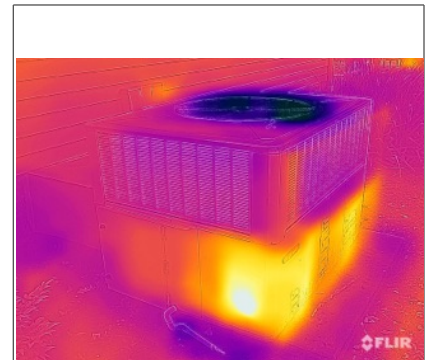
The Trane packaged heat pump for the lower floors was tested and appeared to be functioning properly at time of inspection. Normal operating temperatures were observed at time of inspection.

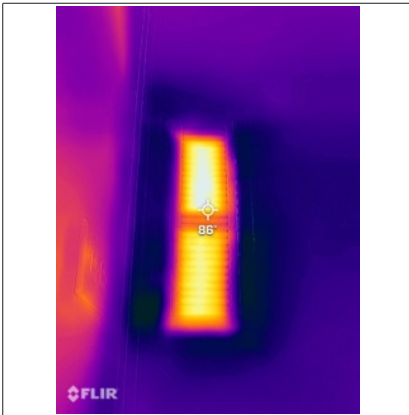
The Trane packaged heat pump for the lower floors was tested and appeared to be functioning properly at time of inspection. Normal operating temperatures were observed at time of inspection.

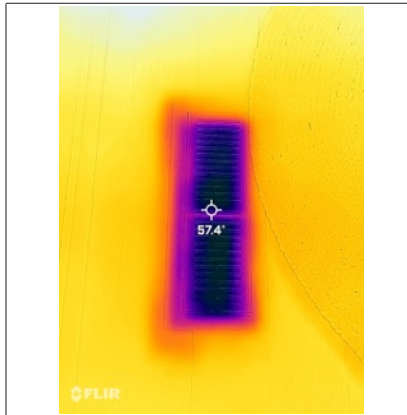
The Trane packaged heat pump for the lower floors was tested and appeared to be functioning properly at time of inspection. Normal operating temperatures were observed at time of inspection.

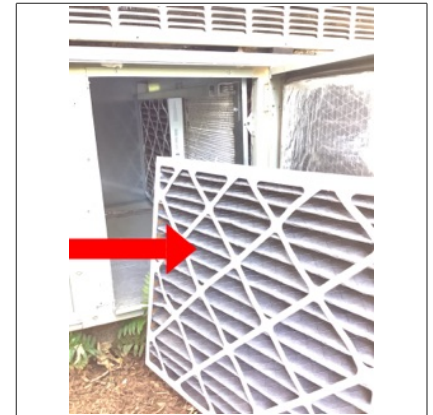
Summary item 6  
The air filters in both HVAC systems were dirty at time of inspection and should be replaced. It appeared that the systems had not been serviced since approximately 09/2020. Recommend general service/cleaning of the HVAC equipment by a licensed contractor if deemed necessary.

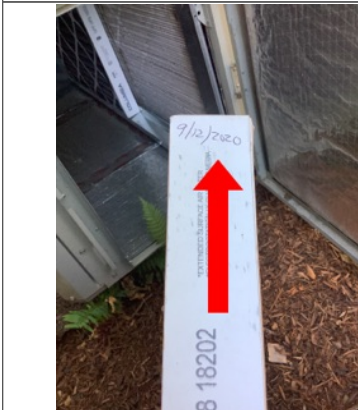
Summary item 6  
The air filters in both HVAC systems were dirty at time of inspection and should be replaced. It appeared that the systems had not been serviced since approximately 09/2020. Recommend general service/cleaning of the HVAC equipment by a licensed contractor if deemed necessary.

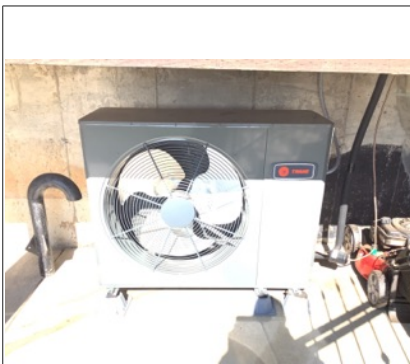
Reference picture of the Trane heat pump

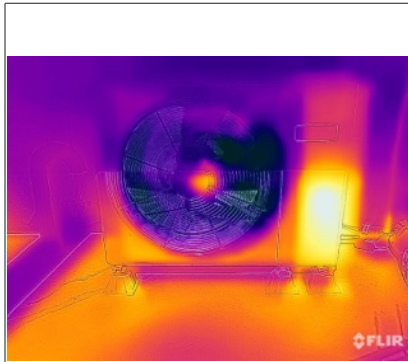
The Trane split system heat pump for the top floor was tested and appeared to be functioning properly at time of inspection. Normal operating temperatures were observed at time of inspection.

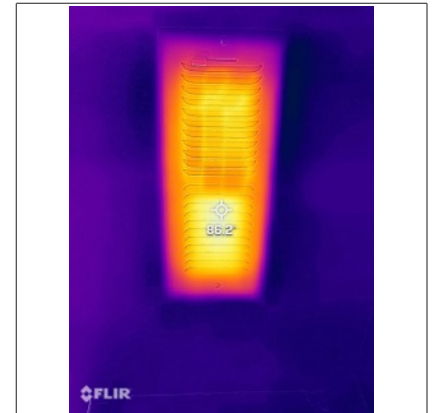
The Trane split system heat pump for the top floor was tested and appeared to be functioning properly at time of inspection. Normal operating temperatures were observed at time of inspection.

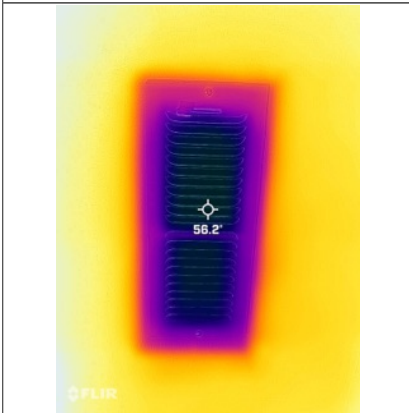
The Trane split system heat pump for the top floor was tested and appeared to be functioning properly at time of inspection. Normal operating temperatures were observed at time of inspection.

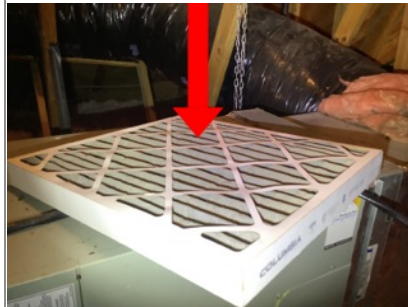
Summary item 6  
The air filters in both HVAC systems were dirty at time of inspection and should be replaced. It appeared that the systems had not been serviced since approximately 09/2020. Recommend general service/cleaning of the HVAC equipment by a licensed contractor if deemed necessary.

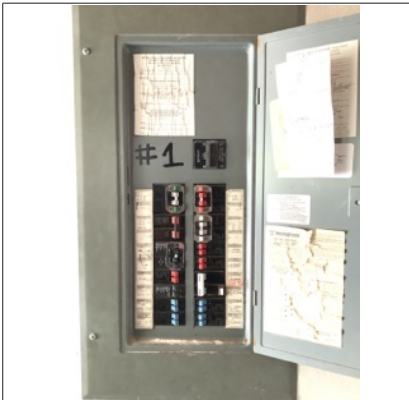
Reference picture of the electrical panel box.
