# Home Inspection Report

123 Anywhere Ln, Hometown, OR 97330

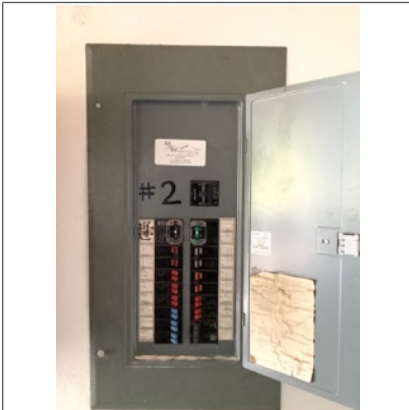
Reference picture of the electrical panel box.

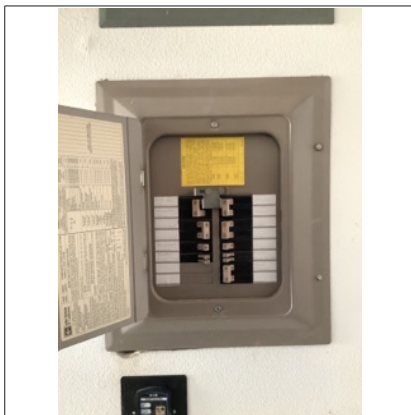
Reference picture of the electrical sub-panel

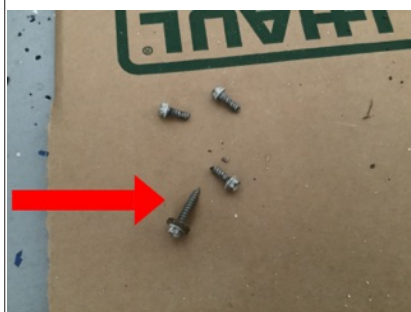
Summary item 7a  
Two of the screws at the electrical sub-panel box cover have pointed ends which are not rated for electrical panels.  
Recommend replacing screws with blunt ended screws rated for electrical panel box covers.

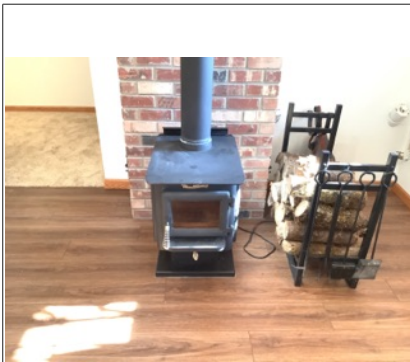
Reference picture of the freestanding wood stove in the basement

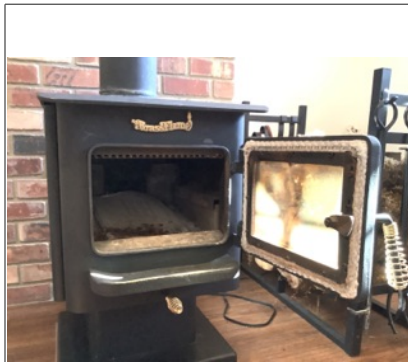
The freestanding wood stove appeared to be in overall usable condition based on a visual inspection only. Flue could not be fully examined so no representation could be made.

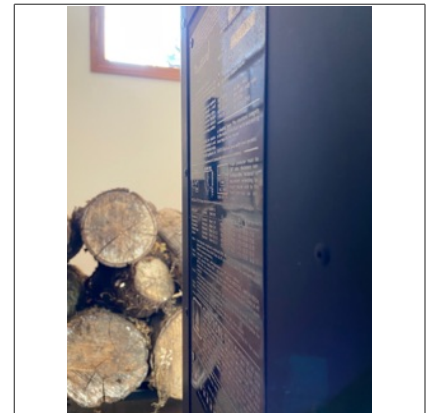
Reference picture of the wood stove rating label showing the EPA certification

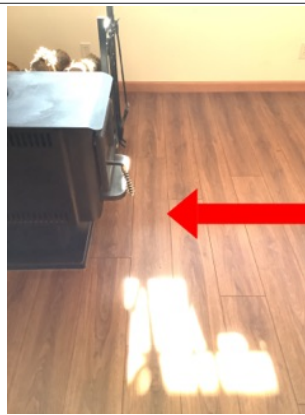
Summary item 1m  
The wood stove was installed without a hearth pad which could allow for embers to damage the flooring in front of the wood stove.

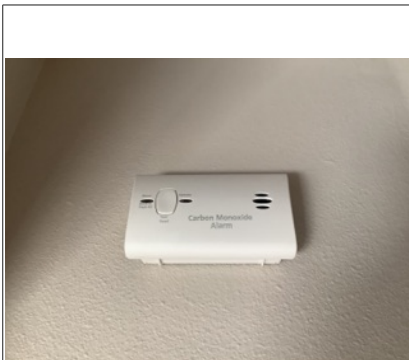
The CO alarms were tested and appear to be functioning properly at time of inspection. Recommend periodic testing of the carbon monoxide alarms to verify working condition.

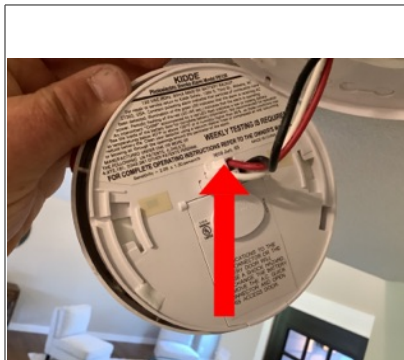
Summary item 4  
 The hardwired smoke alarms (3 total) were over ten years old and should be replaced. Oregon regulations require replacement of smoke alarms at or before 10 years from the manufacture/install date. Recommend replacing the outdated hardwired smoke alarms throughout the home as required. Recommend possible installation of additional smoke alarms in the individual bedrooms as is currently required.

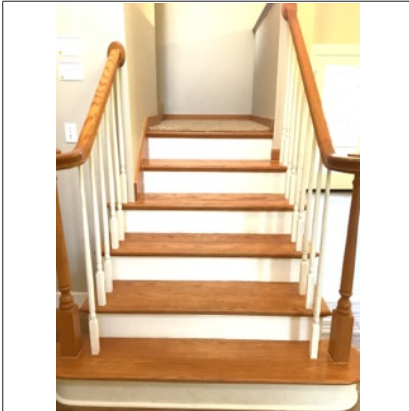
Interior stairs, handrails & balusters appeared to be in overall usable condition.

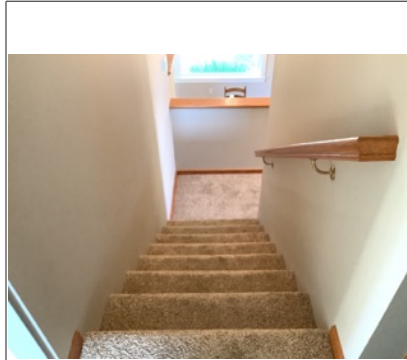
Interior stairs, handrails & balusters appeared to be in overall usable condition.

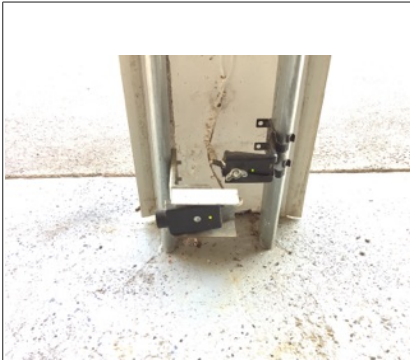
The overhead garage door opener safety features were tested and appeared to be functional unless noted.

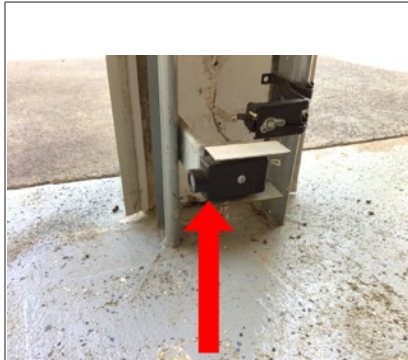
Summary item 1n  
 The optical safety eyes at the westernmost overhead garage door opener appeared to be out of alignment.  
 Recommend aligning the optical safety eyes at the overhead garage door opener to allow for the safety features to function as intended.  
 Recommend testing the close force settings on the overhead garage door opener after aligning the optical safety eyes to ensure the door stops closing when resistance is applied.

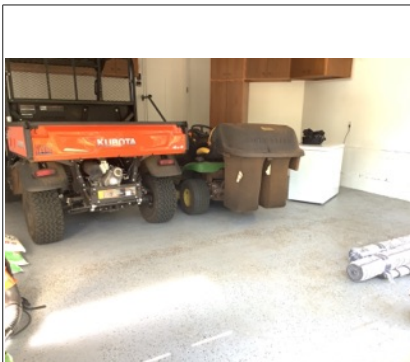
The concrete slab in the garage appeared to be in overall usable condition where visible.

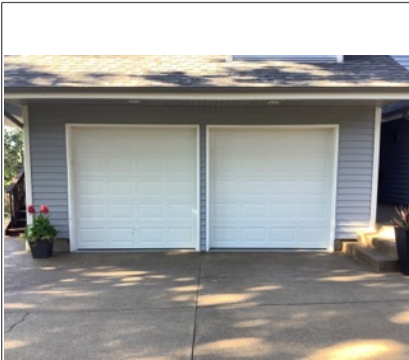
The overhead garage door(s) appeared to be in overall functional condition unless noted

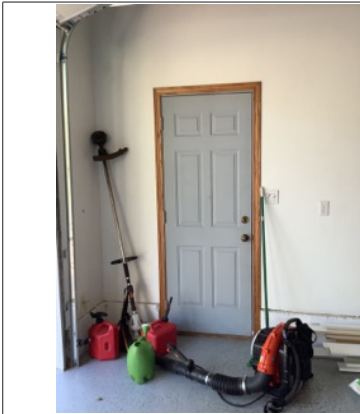
The exterior garage pedestrian door appeared to be in overall usable condition.

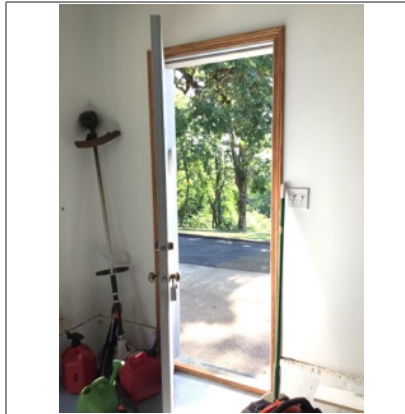
The exterior garage pedestrian door appeared to be in overall usable condition.

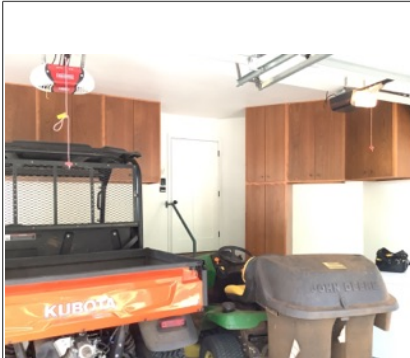
The fire separation between the garage and main living space appeared to be intact and in overall adequate condition unless noted.

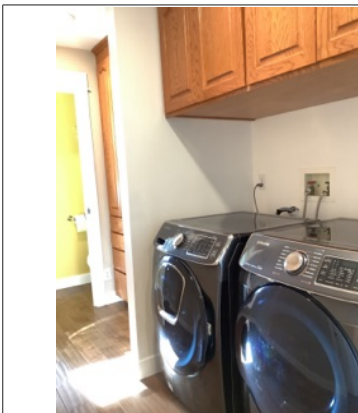
Reference picture of the laundry area

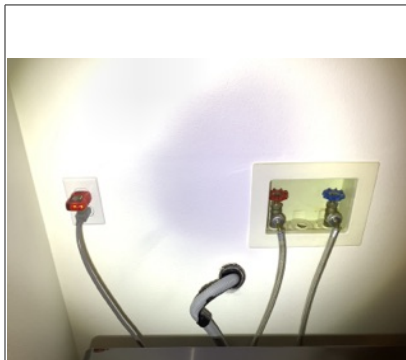
No active water leaks were observed In the laundry room at time of inspection.

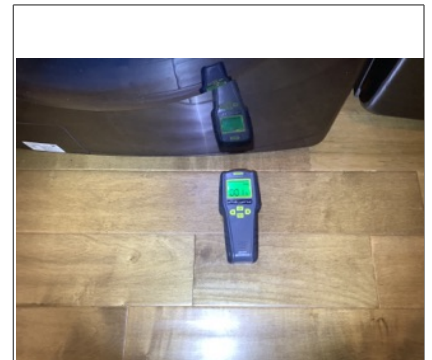
Moisture levels at the subfloor in the laundry room appeared to be within a normal range at time of inspection unless noted. Moisture levels were observed utilizing a pinless moisture meter.

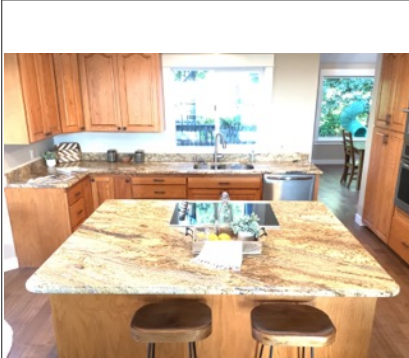
Kitchen countertops appeared to be in overall usable condition.  
Kitchen countertops have normal wear for the age.

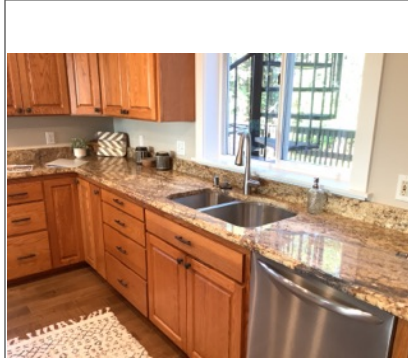
Kitchen countertops appeared to be in overall usable condition.  
Kitchen countertops have normal wear for the age.

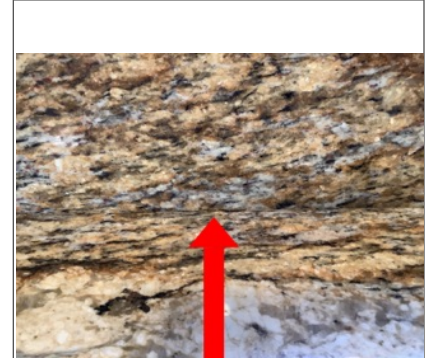
Summary item 10  
Open seams (minimal) were observed between the countertop and the backsplash in the kitchen.

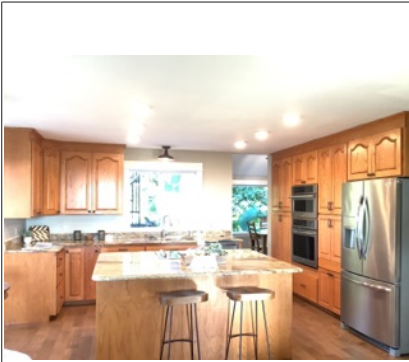
Kitchen cabinets appeared to be in overall usable condition. Kitchen cabinets have normal wear for the age.

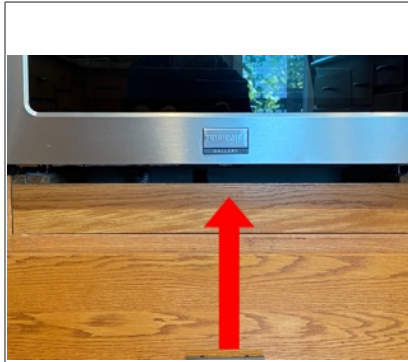
Summary item 1p  
A small strip of wood trim was missing beneath the built-in oven.

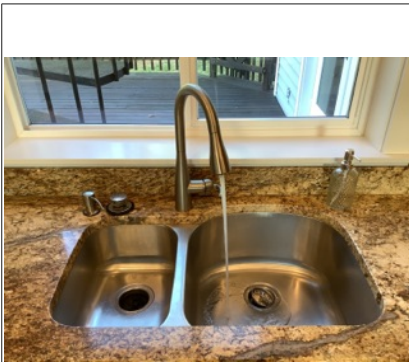
Water flow was normal with several fixtures operated at the same time. There were no visible active piping leaks at the time of the inspection. Drain lines had no visible leaks or signs of backup at the time of inspection.

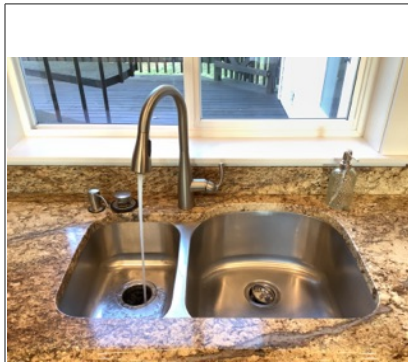
Water flow was normal with several fixtures operated at the same time. There were no visible active piping leaks at the time of the inspection. Drain lines had no visible leaks or signs of backup at the time of inspection.

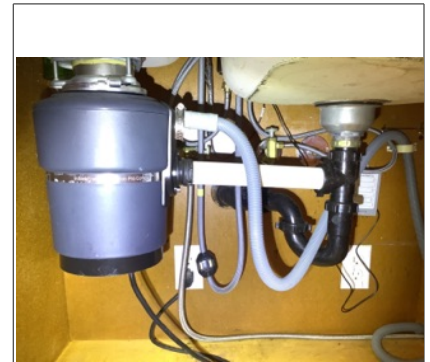
Water flow was normal with several fixtures operated at the same time. There were no visible active piping leaks at the time of the inspection. Drain lines had no visible leaks or signs of backup at the time of inspection.

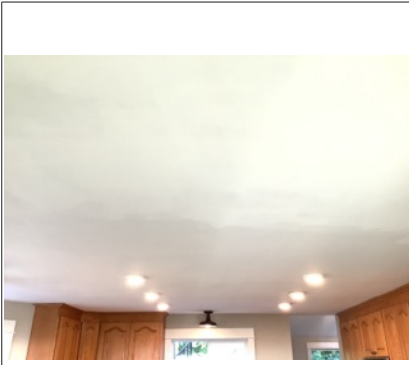
Kitchen wall, ceiling & floor coverings appeared to be in overall adequate condition unless noted.

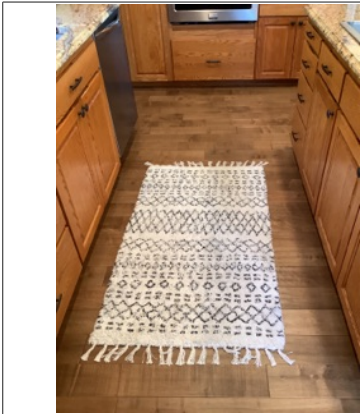
Kitchen wall, ceiling & floor coverings appeared to be in overall adequate condition unless noted.  
No representation can be made for any issues concealed by ceiling, wall or floor coverings.

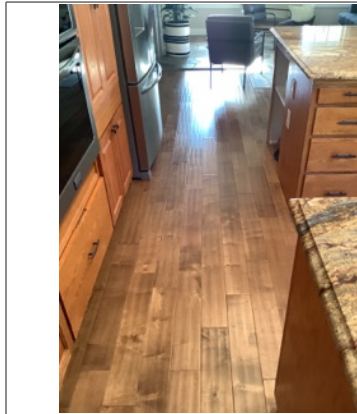
Kitchen wall, ceiling & floor coverings appeared to be in overall adequate condition unless noted.  
No representation can be made for any issues concealed by ceiling, wall or floor coverings.

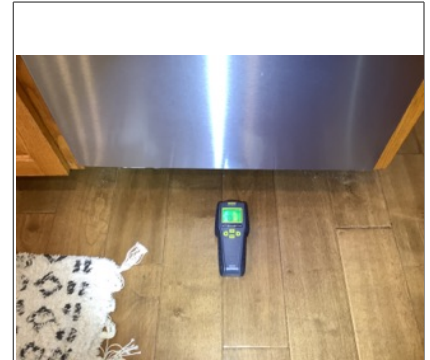
Moisture levels at the subfloor in front of the refrigerator/freezer and the dishwasher appeared to be within a normal range at time of inspection unless noted. Moisture levels were observed utilizing a pinless moisture meter. Inspector cannot move appliances or disturb the floor/wall/ceiling coverings or move insulation at the subfloor. No representation can be made for any issues concealed by ceiling, wall or floor coverings.

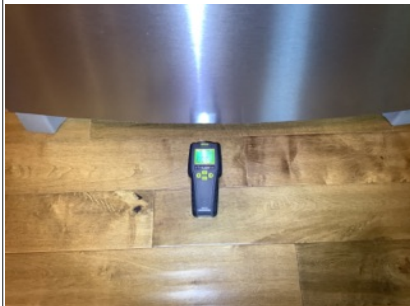
Moisture levels at the subfloor in front of the refrigerator/freezer and the dishwasher appeared to be within a normal range at time of inspection unless noted. Moisture levels were observed utilizing a pinless moisture meter. Inspector cannot move appliances or disturb the floor/wall/ceiling coverings or move insulation at the subfloor. No representation can be made for any issues concealed by ceiling, wall or floor coverings.

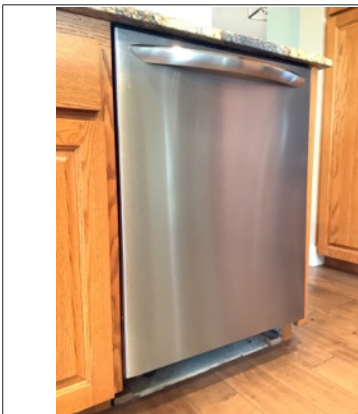
The dishwasher was tested on the "normal cycle and appeared to be functional.  
 No evidence of water leakage was observed under the dishwasher.

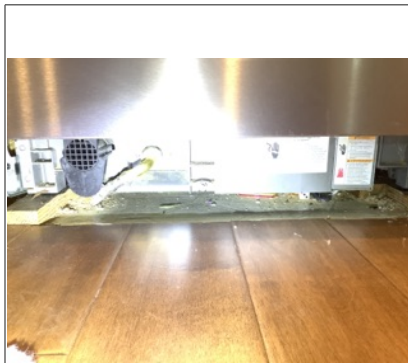
The dishwasher was tested on the "normal cycle and appeared to be functional.  
 No evidence of water leakage was observed under the dishwasher.

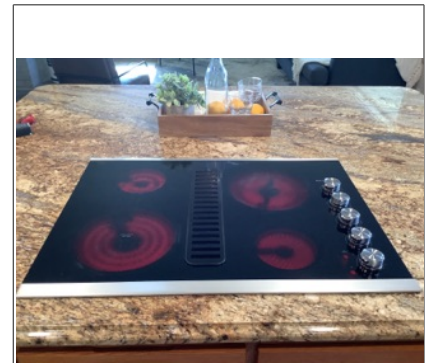
The kitchen range and downdraft exhaust were tested and appeared to be functional.

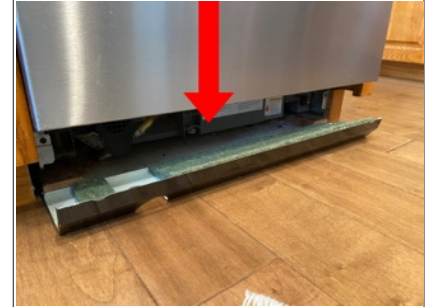
Summary item 1q  
The kick plate at the dishwasher in the kitchen was not installed, possibly due to fitment issues. Recommend installation of the kick plate at the dishwasher or install trim as a substitute.

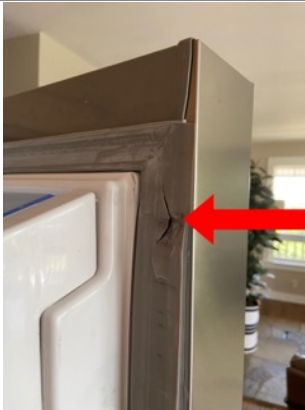
Summary item 1r  
The gasket material at the refrigerator and freezer doors was damaged/cracked and may need to be replaced.  
The refrigerator door mullion was missing and a misplaced/possibly damaged interior storage bin was also observed.  
Recommend an appliance repair technician evaluate and repair as needed.

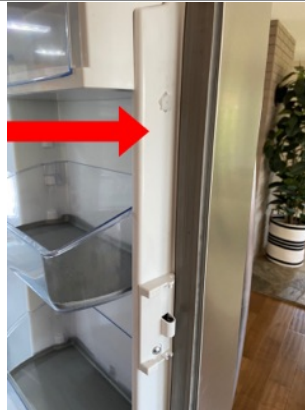
Summary item 1r  
The gasket material at the refrigerator and freezer doors was damaged/cracked and may need to be replaced.  
The refrigerator door mullion was missing and a misplaced/possibly damaged interior storage bin was also observed.  
Recommend an appliance repair technician evaluate and repair as needed.

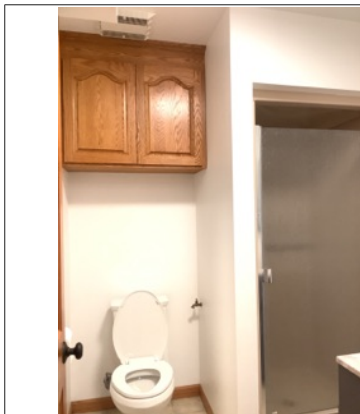
Reference picture of the Basement Bathroom.

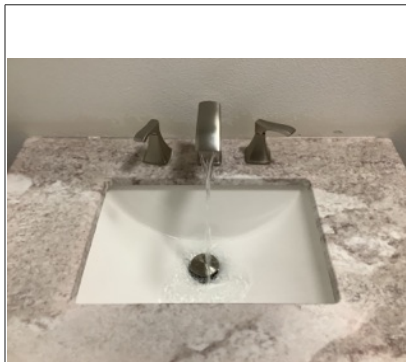
No active water leakage was apparent at time of inspection unless noted.

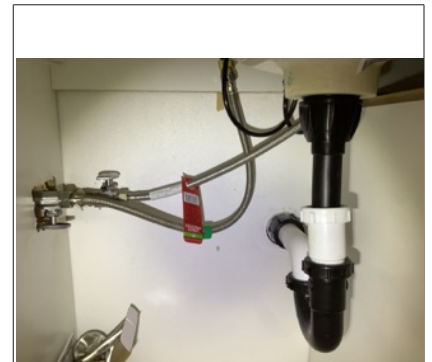
No active water leakage was apparent at time of inspection unless noted.

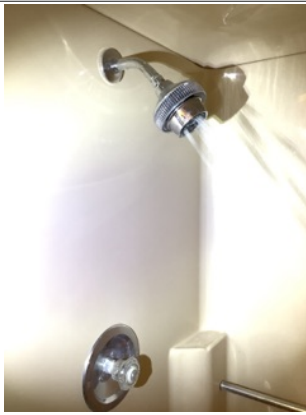
No active water leakage was apparent at time of inspection unless noted.

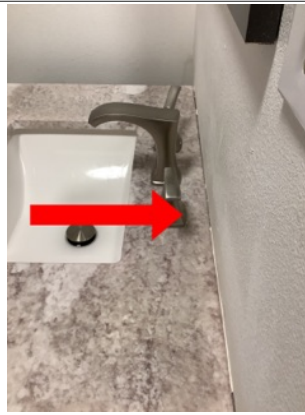
Summary item 1s  
Open seams were observed between the wall and the countertop at the vanity in the basement bathroom.  
Recommend caulking maintenance as needed between the wall and the countertop and/or install a backsplash.

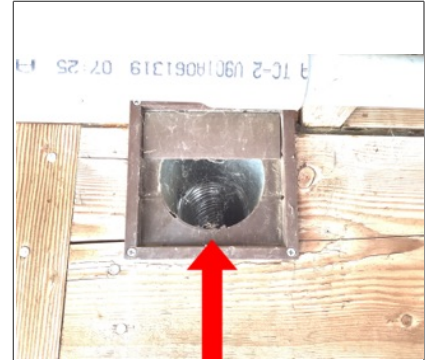
Summary item 1t  
The exhaust fan termination at the exterior of the home East of the Basement Bathroom was missing louvers and may need to be replaced.  
Recommend replacing the damaged exhaust fan termination at the exterior of the home.

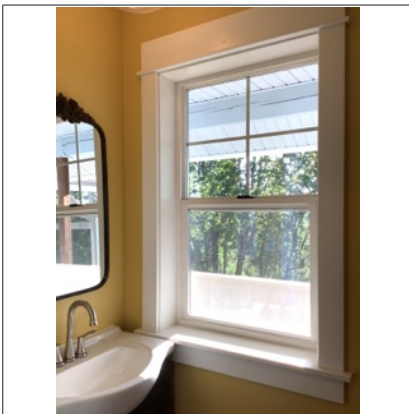
Reference picture of the 1st Floor Half Bath

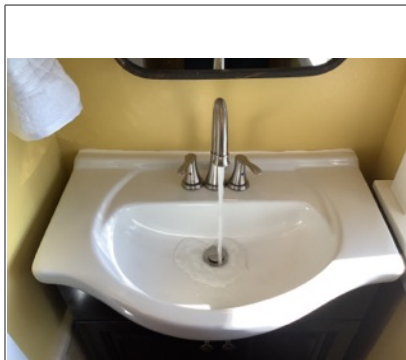
No active water leakage was apparent at time of inspection unless noted.

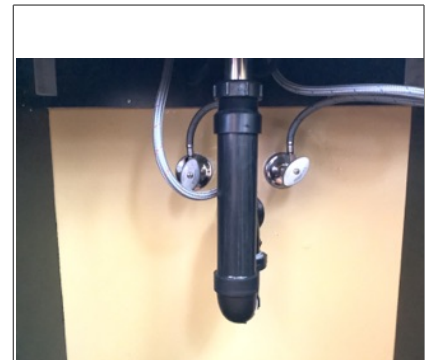
No active water leakage was apparent at time of inspection unless noted.

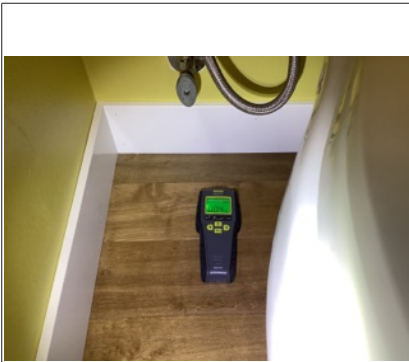
Moisture levels at the subfloor appeared to be within a normal range at time of inspection unless noted. Moisture levels were observed utilizing a pinless moisture meter.

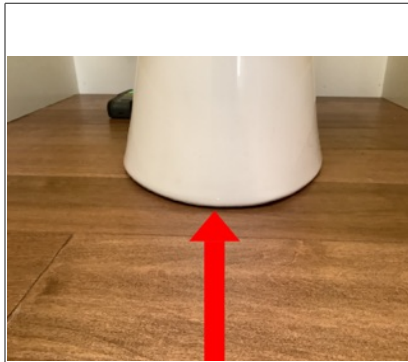
Summary item 1u  
Failed or missing caulking was observed around the toilet base in the 1st Floor Half Bath. Cracked/failed or missing caulking around the front & sides of the toilet can allow for moisture damage under the toilet. Recommend caulking around the front and sides of the toilet base as deemed necessary. A gap in the caulking should always be left at the back of the toilet to allow water to escape if a leak were to occur.

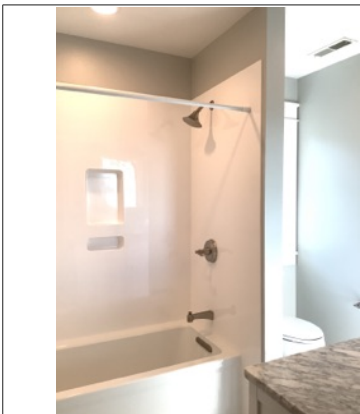
Reference picture of the 2nd Floor Bathroom Northeast

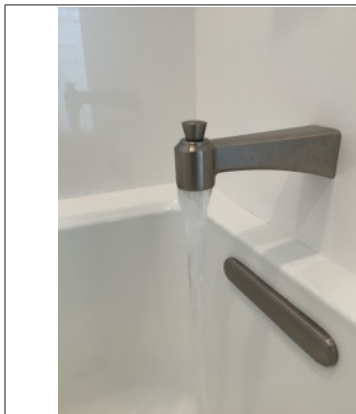
No active water leakage was apparent at time of inspection unless noted.

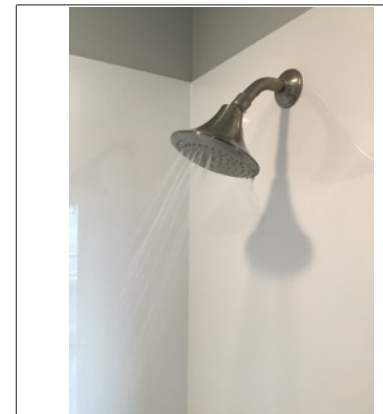
No active water leakage was apparent at time of inspection unless noted.

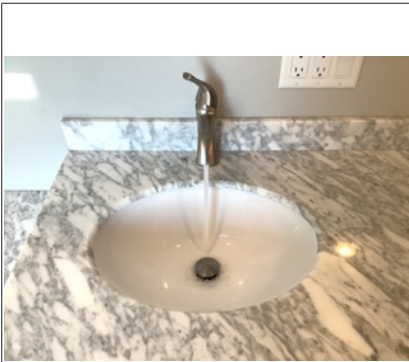
No active water leakage was apparent at time of inspection unless noted.

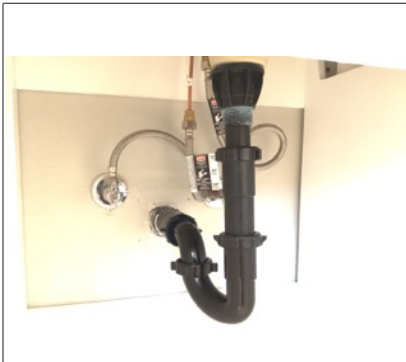
No active water leakage was apparent at time of inspection unless noted.

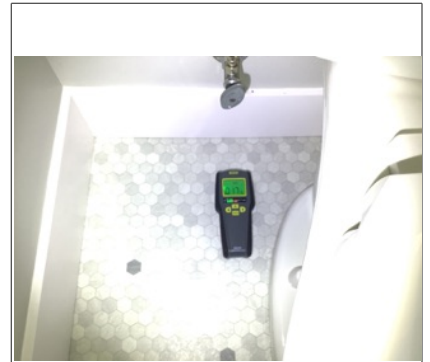
Moisture levels at the subfloor appeared to be within a normal range at time of inspection unless noted.  
Moisture levels were observed utilizing a pinless moisture meter.

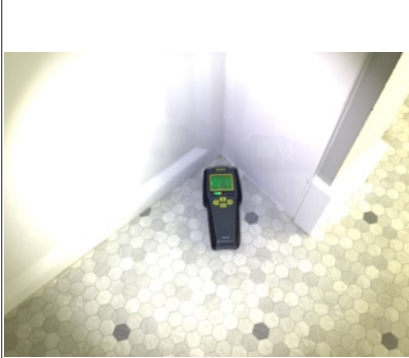
Moisture levels at the subfloor appeared to be within a normal range at time of inspection unless noted.  
Moisture levels were observed utilizing a pinless moisture meter.

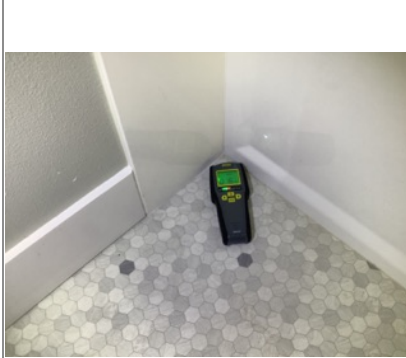
Moisture levels at the subfloor appeared to be within a normal range at time of inspection unless noted.  
Moisture levels were observed utilizing a pinless moisture meter.

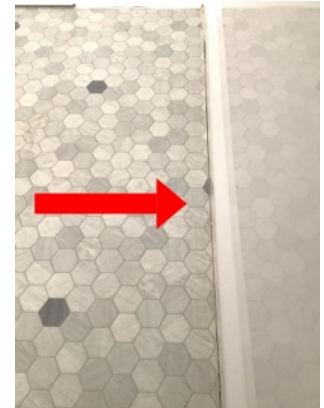
Summary item 1v  
Open seams (minimal) were observed between the floor coverings and the tub/shower in the 2nd Floor Bathroom Northeast.  
Recommend sealing the open gap(s) between the floor coverings and the tub/shower to prevent moisture intrusion and possible damage to the subfloor.

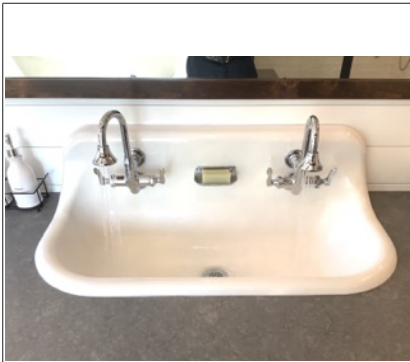
No active water leakage was apparent at time of inspection unless noted.

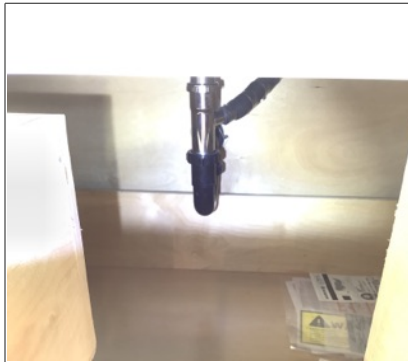
No active water leakage was apparent at time of inspection unless noted.

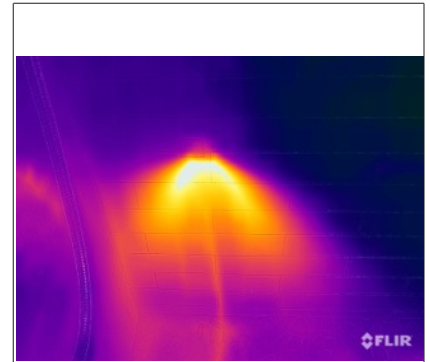
The steam generator in the primary bathroom shower was tested and appeared to be functional.

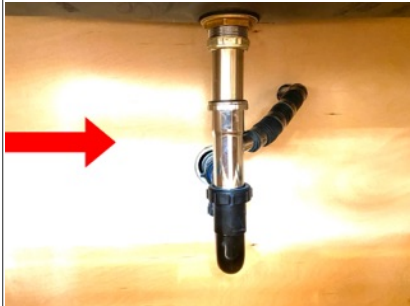
Summary item 5b  
No visible/accessible water shut off valves beneath the sink in the Primary Bathroom.  
2003 IRC P2903.9.3  
Shutoff valves shall be required on each fixture supply pipe to each plumbing appliance and to each plumbing fixture other than bathtubs and showers.  
Valves serving individual plumbing fixtures, plumbing appliances, risers and branches shall be accessible.  
Recommend consulting the current occupant regarding the location of any water shut off valves serving the sink and/or install accessible shut off valves as required.

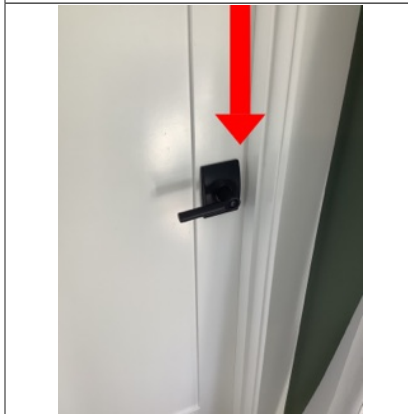
Summary item 1w  
The interior door at the primary bathroom would not latch when closed.  
Recommend adjusting the door/door hardware as needed to allow the door to latch as deemed necessary.

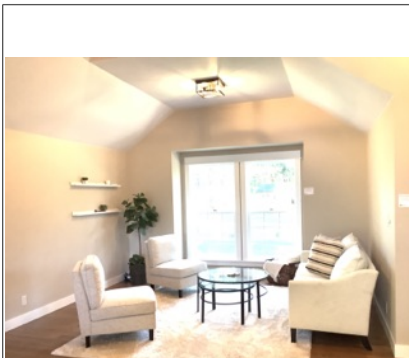
Reference picture of the Living Room

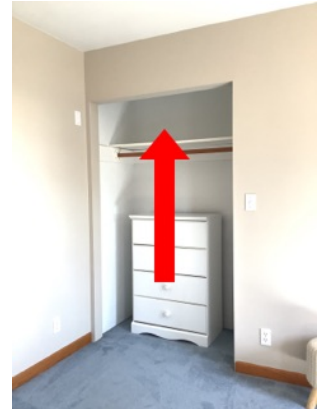
Summary item 1x Missing closet doors were observed in the 2nd floor bedrooms. Recommend installation of replacement closet doors where indicated as deemed necessary.

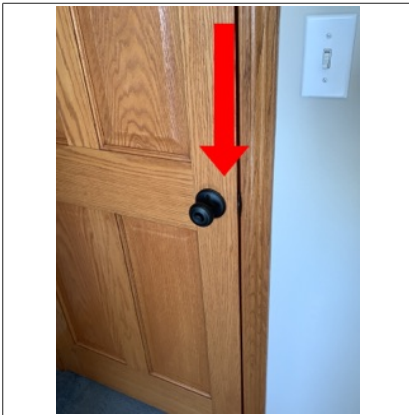
Summary item 1y  
 The interior door at the 2nd Floor Bedroom East would not latch when closed.  
 Recommend adjusting the door/door hardware as needed to allow the door to latch as deemed necessary.

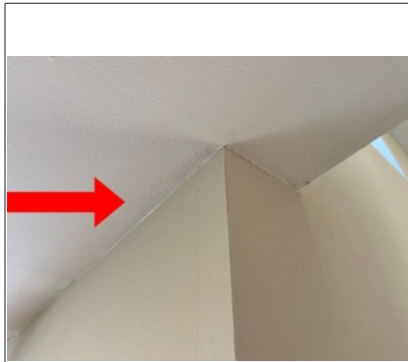
Summary item 1z  
 Minor cosmetic blemishes typical for previously occupied homes were observed at time of the inspection.  
 Worn/stained carpeting was observed with the area of primary concern observed in the stairway.  
 Painting maintenance was needed with the area of primary concern observed on the main floor around the kitchen/family room areas.  
 Cosmetic issues are not part of a home inspection in Oregon and would only be documented as a courtesy.  
 Recommend repair of any/all cosmetic blemishes throughout the home as deemed necessary.

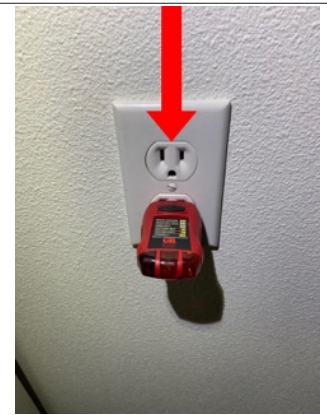
Summary item 7b  
 No voltage was present at the electrical outlets on the North, East and South sides of the basement.  
 All circuit breakers in the electrical panel boxes were on and all known GFCI resets were checked.  
 There may be a GFCI or switch which was not located that provides power to the outlets in the basement.  
 Recommend consulting the current homeowner(s) or a licensed electrician for further review.

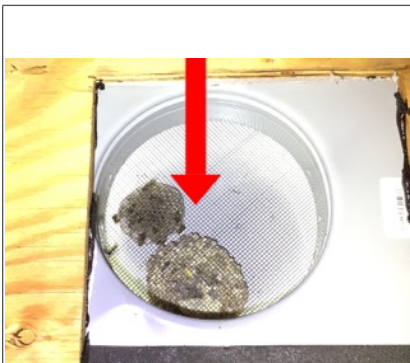
Summary item 9  
 Wasp/yellow jacket activity was observed at the soffits, exterior light fixtures, behind the vinyl siding/trim and in the box vents on the roof visible from inside the attic.  
 Recommend treatment/removal of all wasp, yellow jacket and hornet activity around the home as needed.

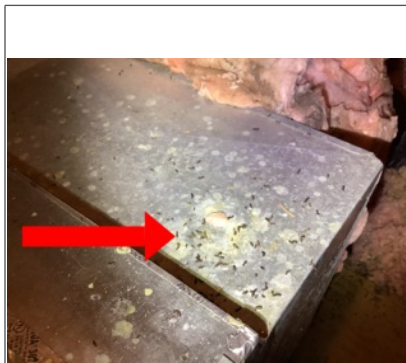
Summary item 9a  
 Evidence of past/possibly current rodent activity (mouse droppings/deceased mice) were observed in the crawl space and attic.  
 Recommend sealing any/all potential access points around the exterior of the home.  
 Recommend monitoring for rodent activity or consult a licensed pest applicator for further evaluation.
